1 Building Management System

1.1 Background

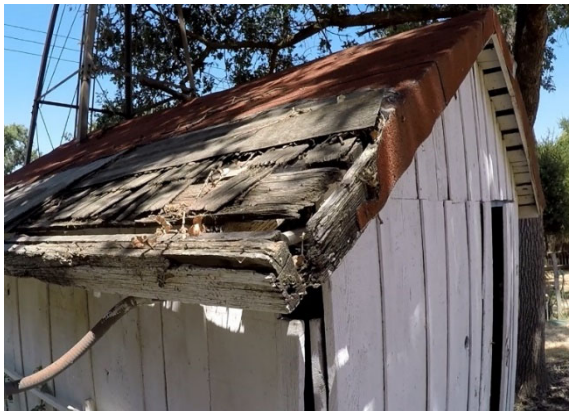
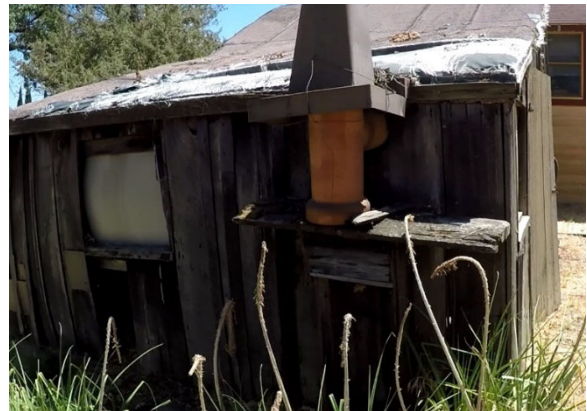
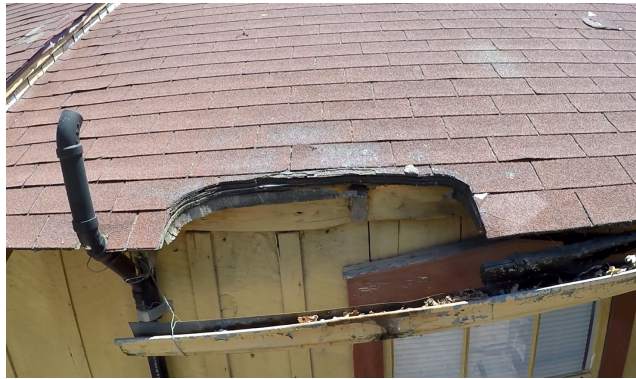
Figure 1-10 Hagemann Farm Roof and Gutter Condition

During the inventory verification and development process, each building in the register was visited and the asset condition was assessed. Assets with replacement and rehabilitation needs were highlighted. Some issues found in the on-site assessment are illustrated in the images of historic Hagemann Farm below. These images depict failed or failing (condition 5) roofs and gutters.

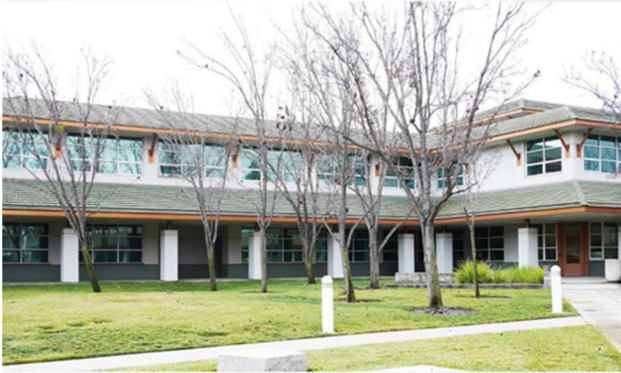
1052 South Livermore Ave.

- UPS needs maintenance
- UPS battery needs replacement
- Non-rated doors need replacement
- Air conditioning units need replacement
- Condensing units need replacement
- Card readers need maintenance
- CCTV systems need maintenance
- Door hardware need maintenance
- Strobes need maintenance
- Vinyl floors and carpets need maintenance

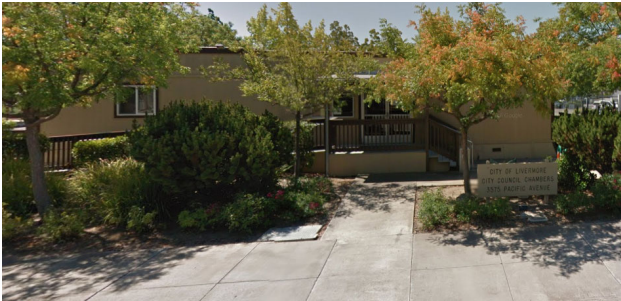
- Facility does not have a seismic gas shutoff valve on the gas meter as per Health and Safety Code 19180-19183.
- Verify red breaker in electrical panel for fire alarm control panel as per NFPA 72 – 10.6.5.2.3.
- Railings at stairs and ramp not compliant with CBC Chapters 10 and 11.
- Restrooms need to be verified for CBC Chapter 11 compliance.
- Water fountain not compliant.
- No emergency exit signage at main entrance.
- Verify that all P trap boots are on in the restrooms, per CBC 11B-606.5.

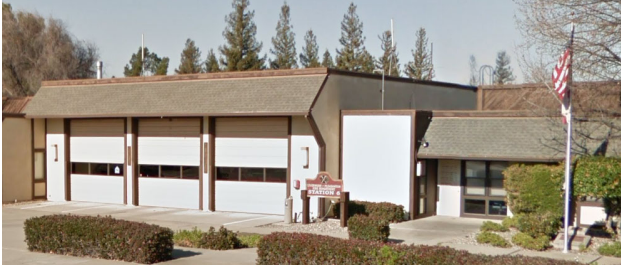
4550 East Avenue

- Facility does not have a seismic gas shutoff valve on the gas meter as per Health and Safety Code 19180-19183.
- Verify that fire alarm is not required. Verify with the City Fire Marshal that a fire alarm system is not required for the building proper.

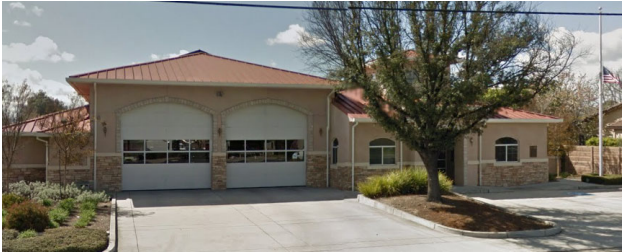
951 Rincon Ave.

- Facility does not have a seismic gas shutoff valve on the gas meter as per Health and Safety Code 19180-19183.
- Verify that the requirements of the Health and Safety Code Section 16000-16001 which pertains to an “Essential Services” facility which a fire station falls under by state code as noted.
- Electrical room is being used for storage. Not allowed by CBC and CEC.
- Water heater closet is being used for storage.
- Verify that exit signs denote correct egress from the building. Review found exit signage lacking.
- Provide panel and circuit numbers on the infrastructure units (HVAC, water heater, etc.), to better assist in maintenance or replacement.

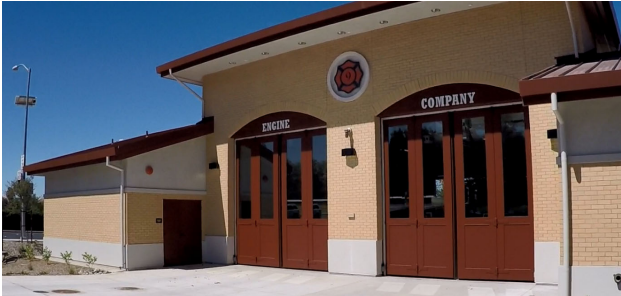
1919 Cordoba St.

- Verify red breaker in electrical panel for fire alarm control panel as per NFPA 72 – 10.6.5.2.3.
- Peeling concrete stain in dining area.
- Storage around fire sprinkler standpipe.
