1 Wall Management System

1.1 Background

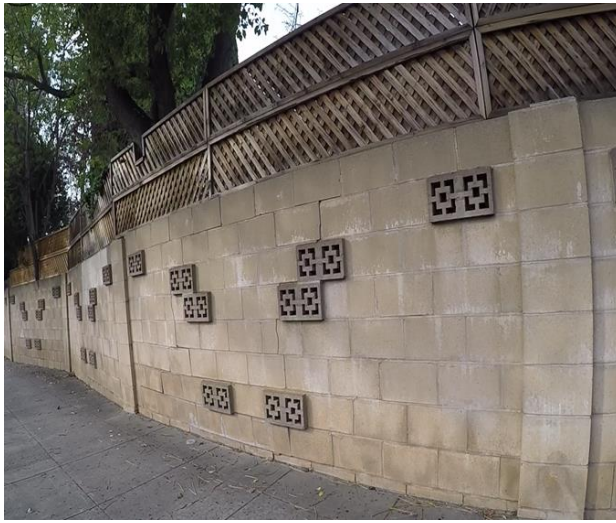
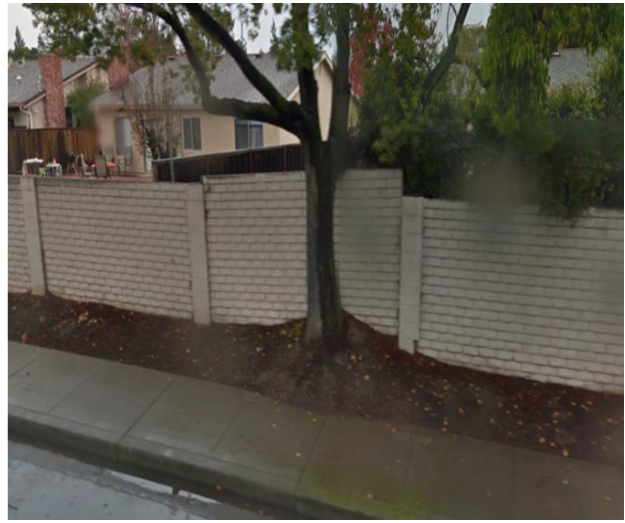
Figure 1-14 Condition 4 Wall Example

The following pictures illustrate condition 4 walls. The wall pictured on the left is bulging and leaning likely due to backfill pressure and a tree pushing against the wall, while the wall on the right is raised off of the ground by the tree root. Although still standing, these walls will need to be addressed in the near future.

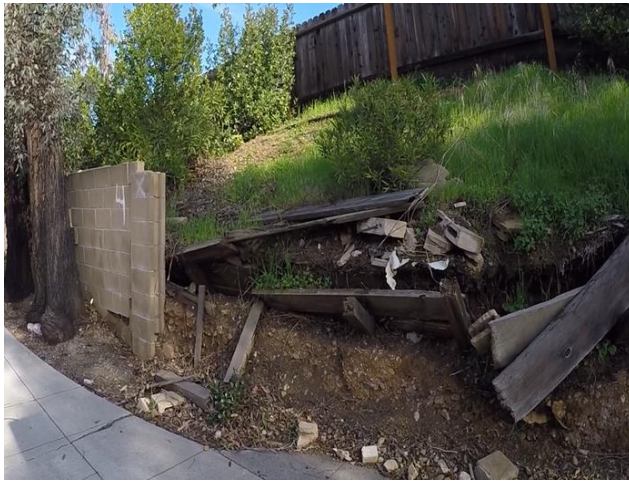
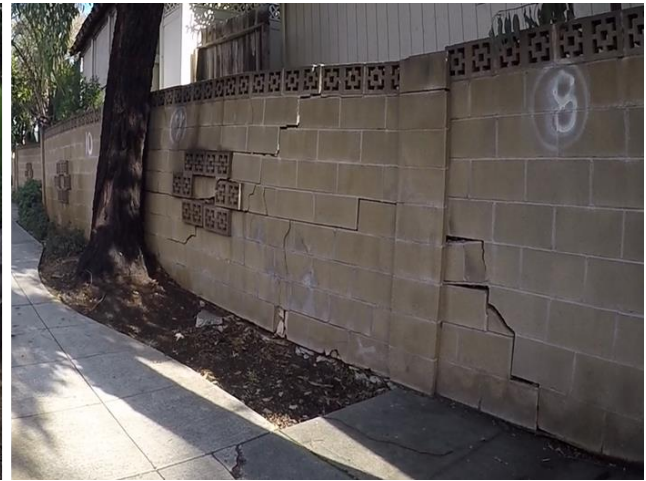
Figure 1-15 Wall Condition 5 Example

The walls in the images below show examples of condition 5 walls, or walls that are now failing or have failed. A large portion of the wall pictured on the left has completely collapsed and many areas of the wall on the right have large structural cracks, the wall is bulging, and raised off the ground by the tree.

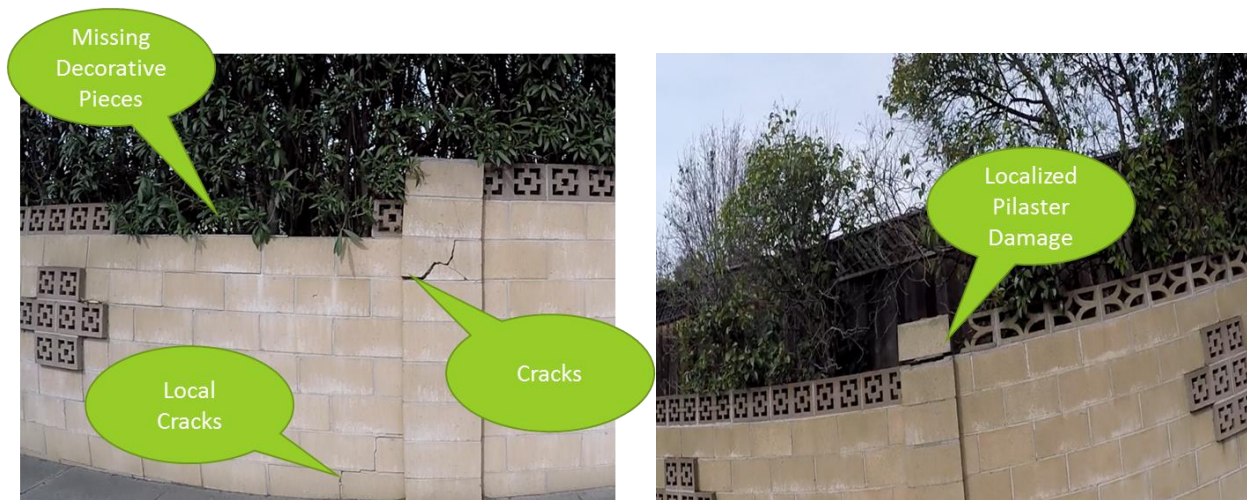
Figure 1-17 Wall Repair Example

The following images are of the wall along Portola Avenue, on the north side of the road from Yorkshire Drive to Royal Road. This wall shown is in good enough condition to require only repair work rather than needing full replacement. The damage shown here was caused by trees on the resident's side of the wall but can be repaired by mortar/grouting.

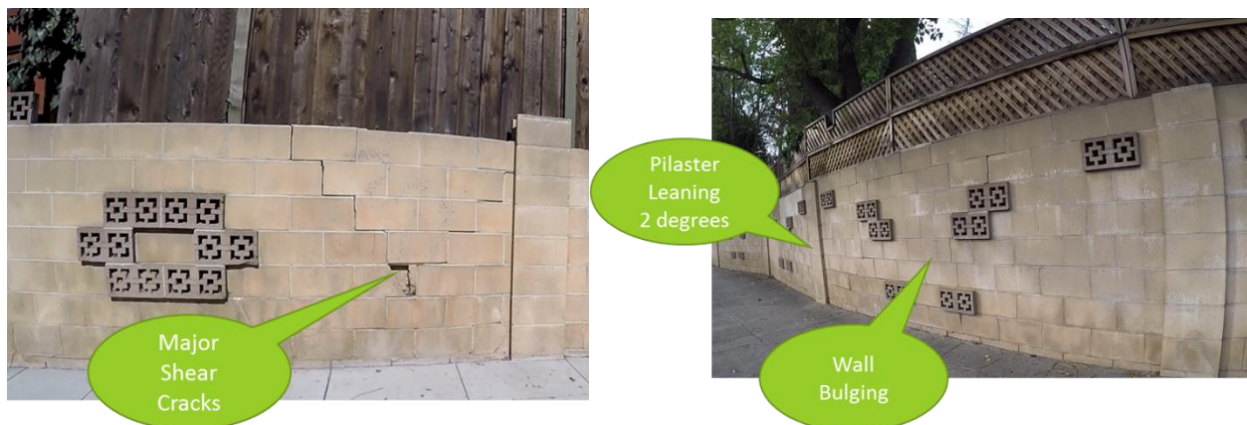
Figure 1-18 Wall Replacement Example

Figure 1-18 shows the wall along E Jack London Boulevard, on the north side of the road from Murrieta Boulevard to Troy Street. The walls that are bulging or leaning in several areas. In the case of these walls, with the extent of the wall damage present, multiple panels of wall would be in need of full replacement.
