# 1 Building Management System

## 1.1 Background

### 1.1.1 What Services Do These Assets Provide?

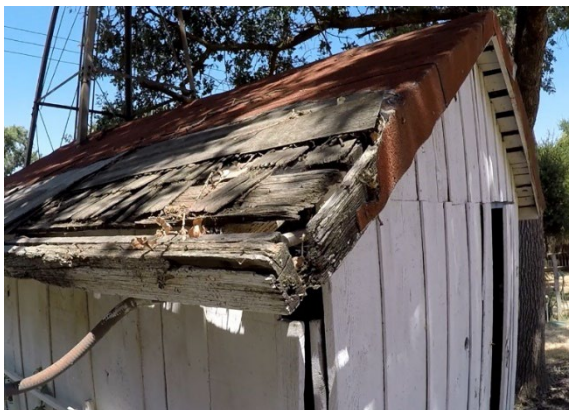
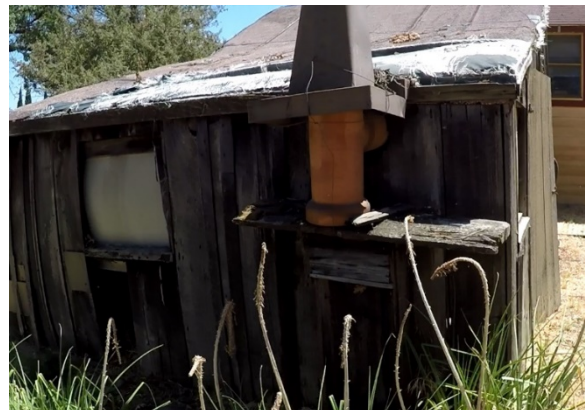
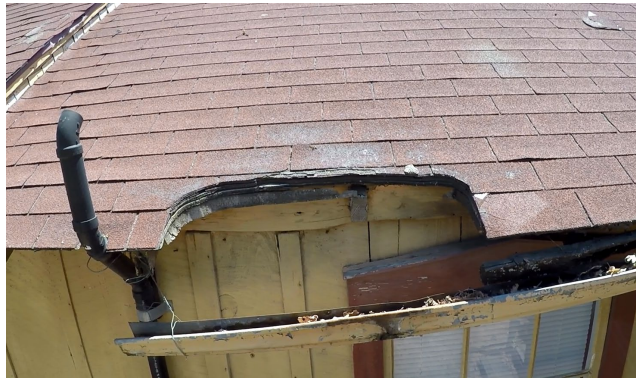
*Figure 1-10 Hagemann Farm Roof and Gutter Condition*

During the inventory verification and development process, each building in the register was visited and the asset condition was assessed. Assets with replacement and rehabilitation needs were highlighted. Some issues found in the on-site assessment are illustrated in the images of historic Hagemann Farm below. These images depict failed or failing (condition 5) roofs and gutters.

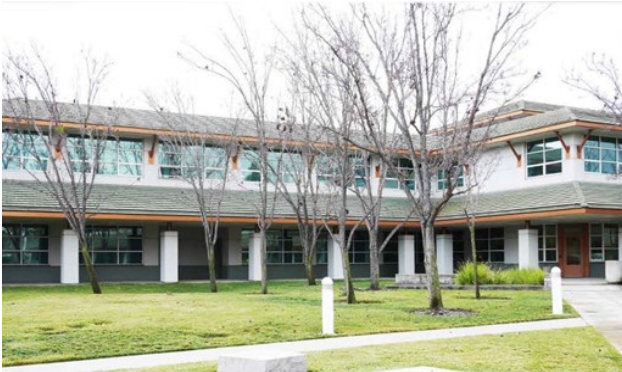
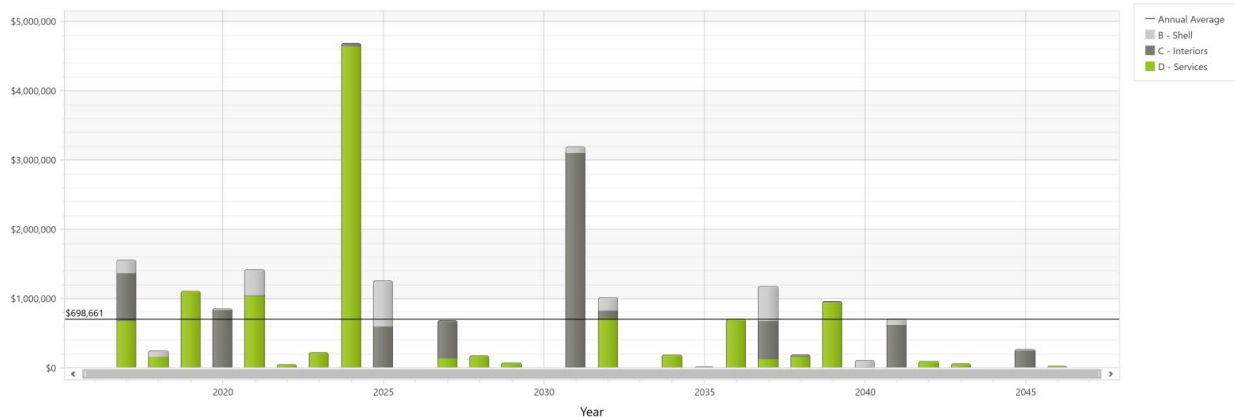
**City Hall Immediate Needs**

- UPS needs maintenance
- UPS battery needs replacement
- Non-rated doors need replacement
- Air conditioning units need replacement
- Condensing units need replacement
- Card readers need maintenance
- CCTV systems need maintenance
- Door hardware need maintenance
- Strobes need maintenance
- Vinyl floors and carpets need maintenance

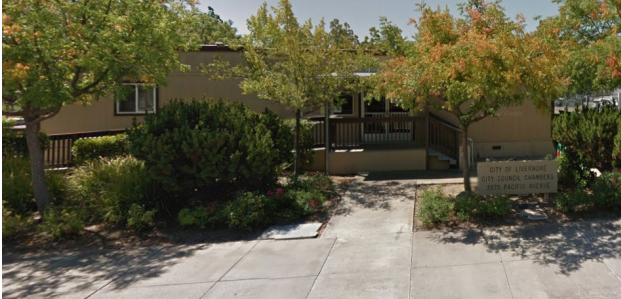
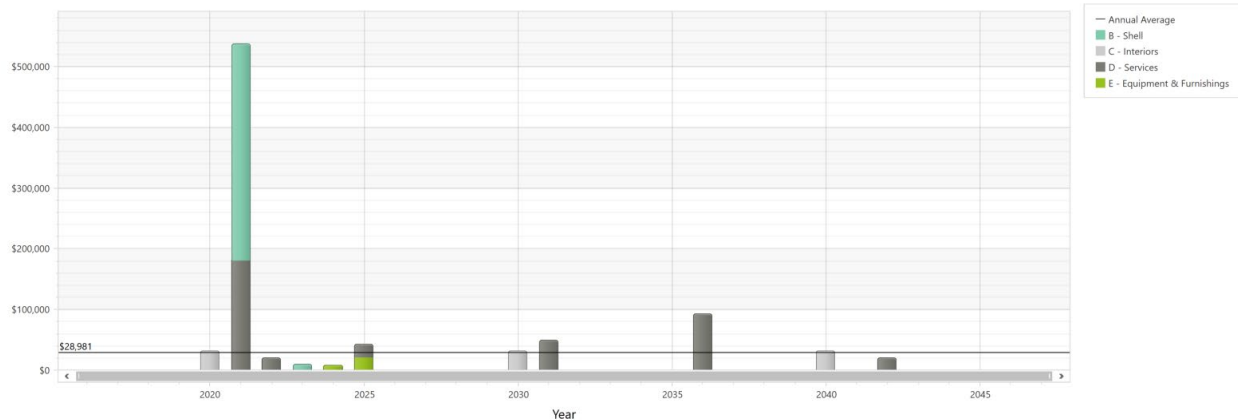
### Council Chambers Immediate Needs

- Facility does not have a seismic gas shutoff valve on the gas meter as per Health and Safety Code 19180-19183.
- Verify red breaker in electrical panel for fire alarm control panel as per NFPA 72 – 10.6.5.2.3.
- Railings at stairs and ramp not compliant with CBC Chapters 10 and 11.
- Restrooms need to be verified for CBC Chapter 11 compliance.
- Water fountain not compliant.
- No emergency exit signage at main entrance.
- Verify that all P trap boots are on in the restrooms, per CBC 11B-606.5.

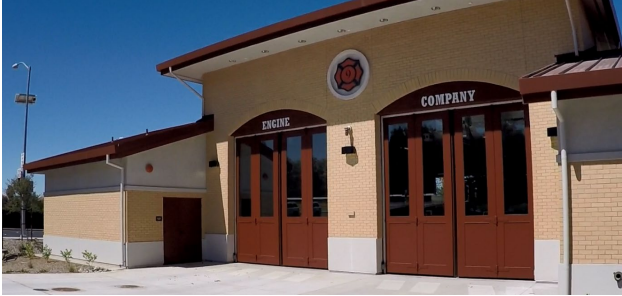
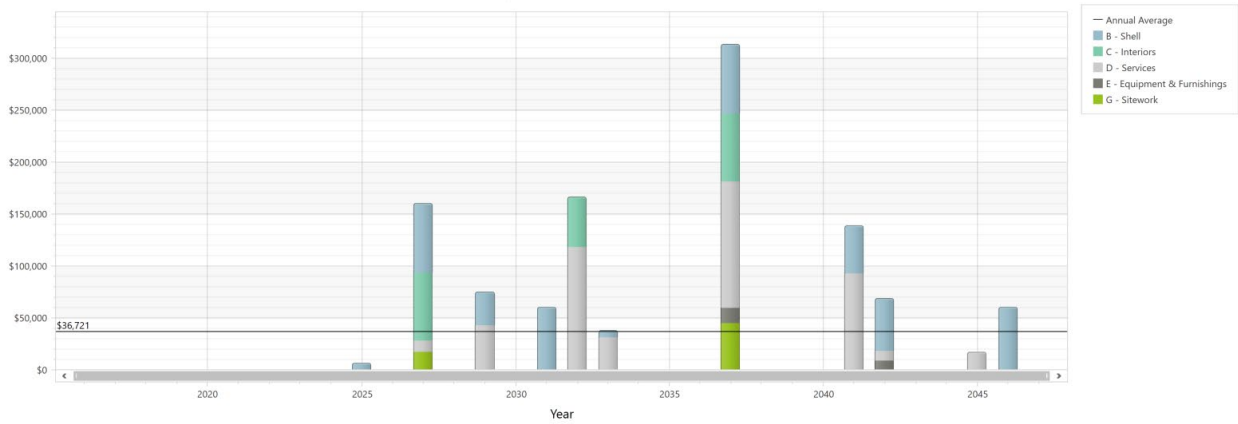
**Fire Station 9 Immediate Needs**

- Verify red breaker in electrical panel for fire alarm control panel as per NFPA 72 – 10.6.5.2.3.
- Peeling concrete stain in dining area.
- Storage around fire sprinkler standpipe.
