CAMP Meeting - Walls

City of Livermore

December 5, 2016 – This presentation was revised after meeting.

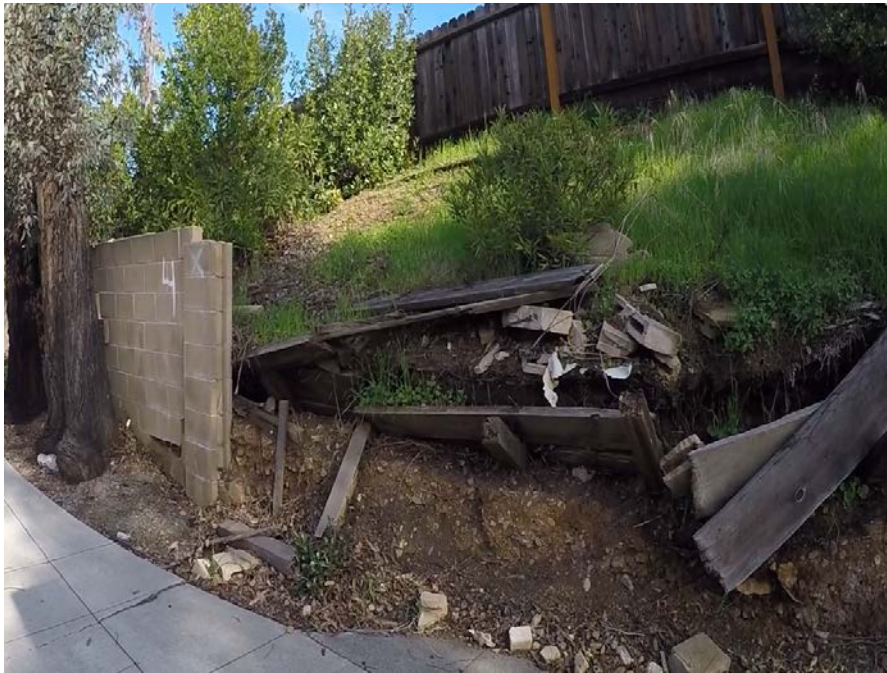
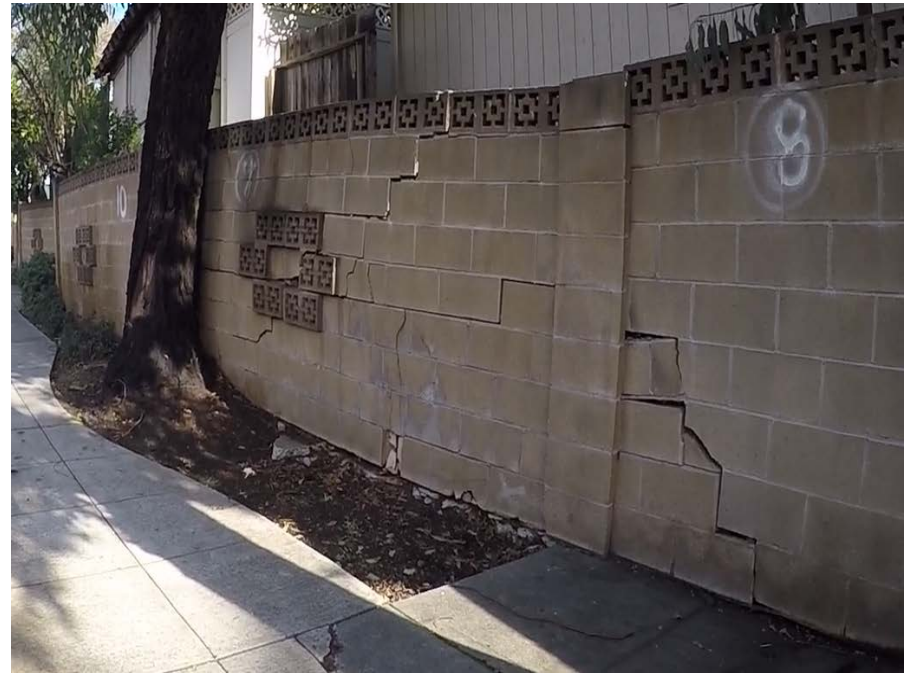
Condition 5

Scale	Description
1	New or nearly new
2	Very good
3	Good
4	Poor or recommended replacement within near-term
5	Failed or nearing failure, needs immediate attention

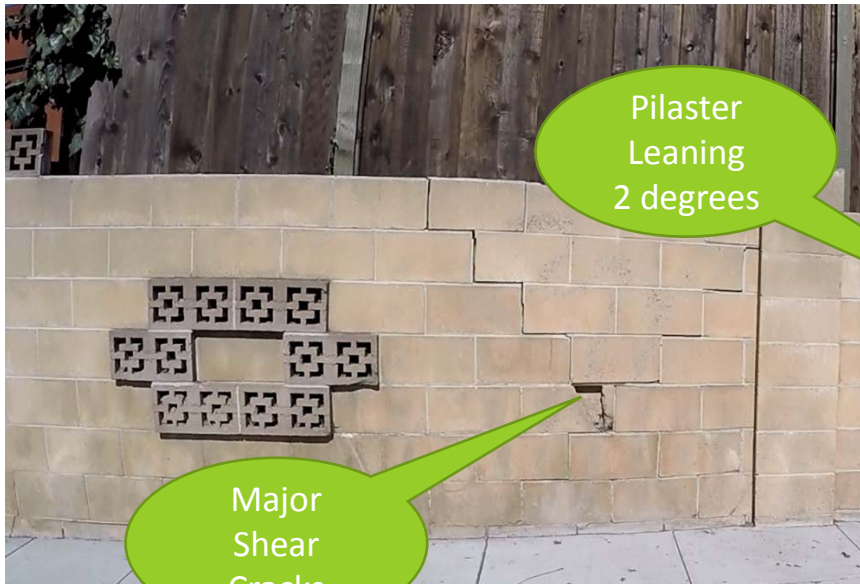
- Example: E Jack London Blvd (North) from Murrieta Blvd to Troy St
 - Summary: Bulging, leaning 2 degrees in several areas, multiple panels in need of full replacement, damage to pilasters and bottom course

Pilaster
Leaning
2 degrees

Major
Shear
Cracks

- Walls recommended for replacement
 - Condition 4 and 5 walls
 - Areas of major damage in multiple places along the wall (e.g., bulging, leaning more than 2 degrees, major cracking)
- Walls recommended for rehabilitation/repair
 - Localized areas of damage
 - Can be fixed with repair or panel replacement

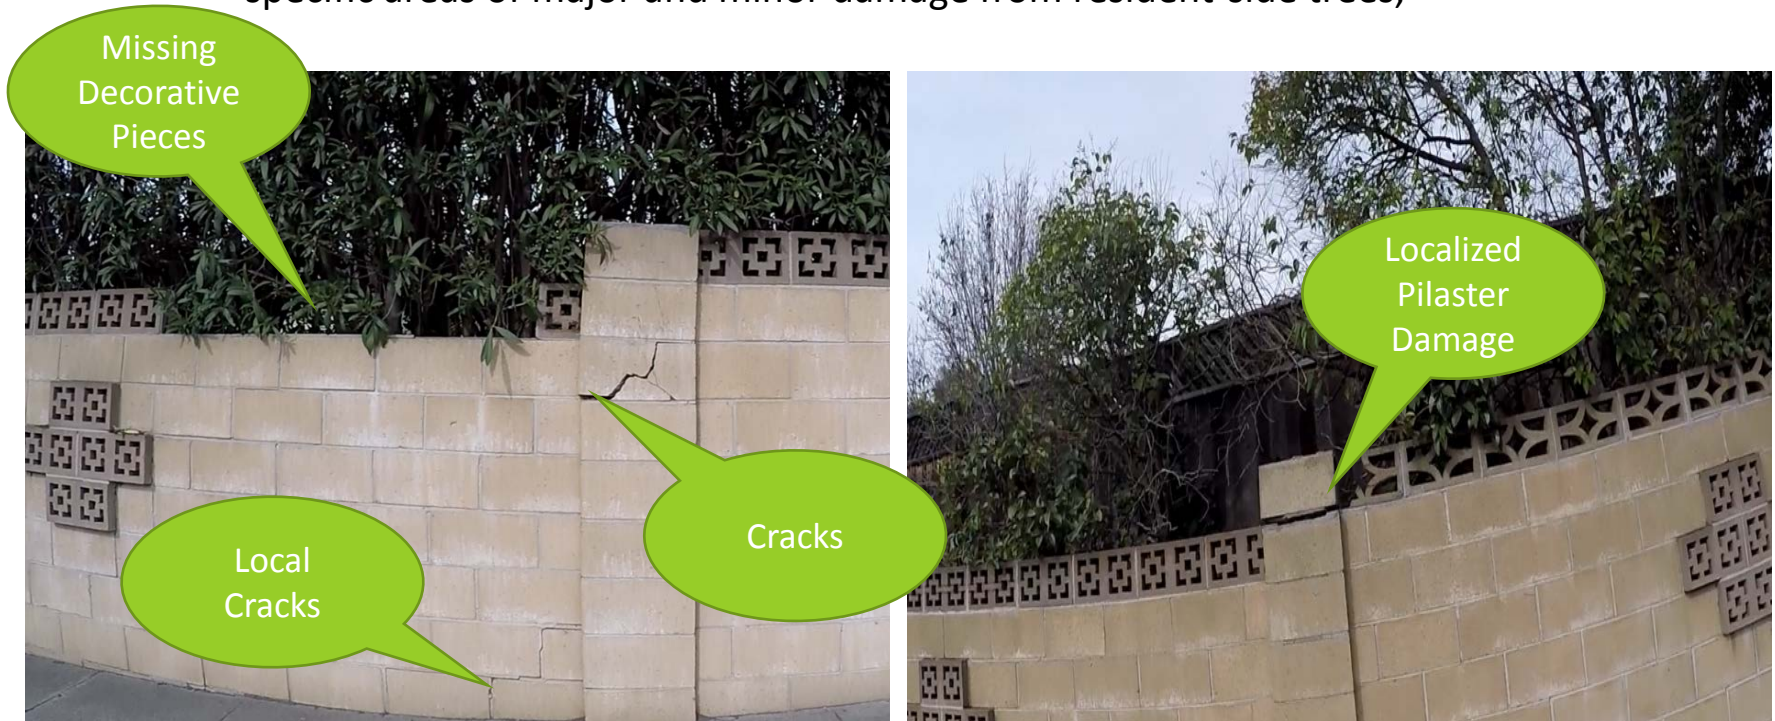
- Example: Portola Ave (North) from Yorkshire Dr to Royal Rd
 - Summary: Areas of bottom course damage - can be repaired by mortar/grouting, specific areas of major and minor damage from resident-side trees,
