# 1 Bridge Management System

## 1.1 Background

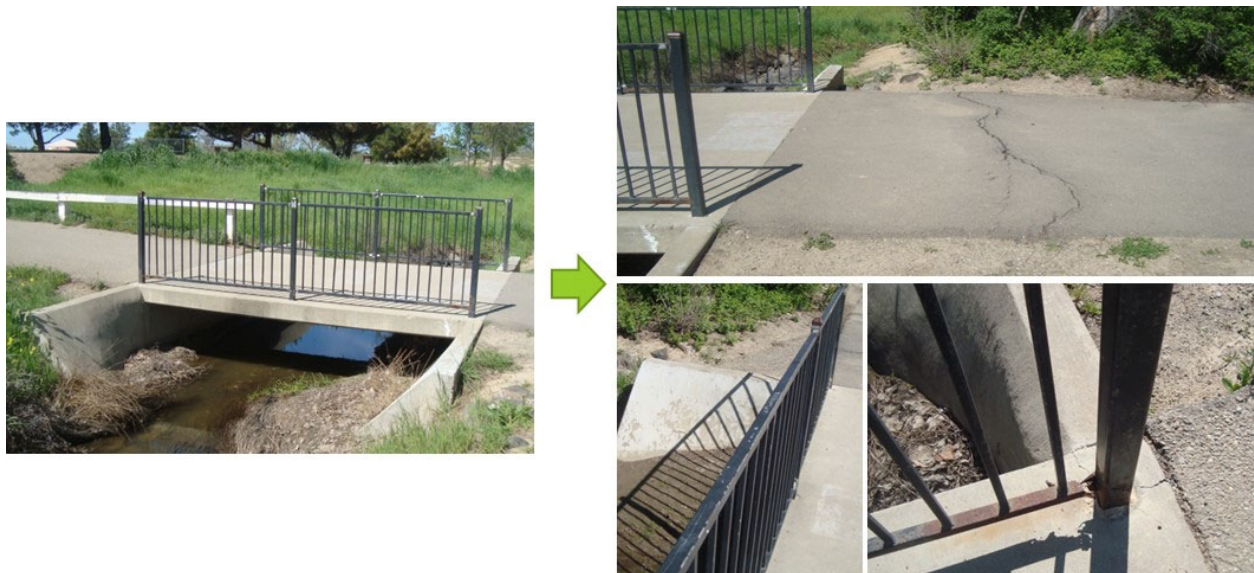
*Figure 1-14 Condition Score Examples*

The image on the left shows the overview of the bridge and the images on the right highlight some of the condition issues that were found during inspection. The image on the upper right shows the wearing of the Portland cement concrete (PCC) deck surface. The deck is 80 square feet, 75 square feet is in good condition but the wear is concentrated on about 5 square feet, making this small area considered to be in fair condition. The bottom images show the minor to moderate rusting on the metal railing. Out of 16 total feet of railing, about 4 feet is in good condition, 4 feet is in fair condition, and 8 feet is in poor condition (bottom right image).

It would be recommended that the lower rail at the ends should be re-weld and the railings should be re-painted. The cracks at the post bases of the deck need to be epoxied and the vertical cracks in the AC at approaches should be re-sealed. Lastly, sediment under the bridge should be removed to maximize channel hydraulic capability.
