## **CAMP Committee Meeting**

City of Livermore

July 17, 2017

## Storm Drain Management System

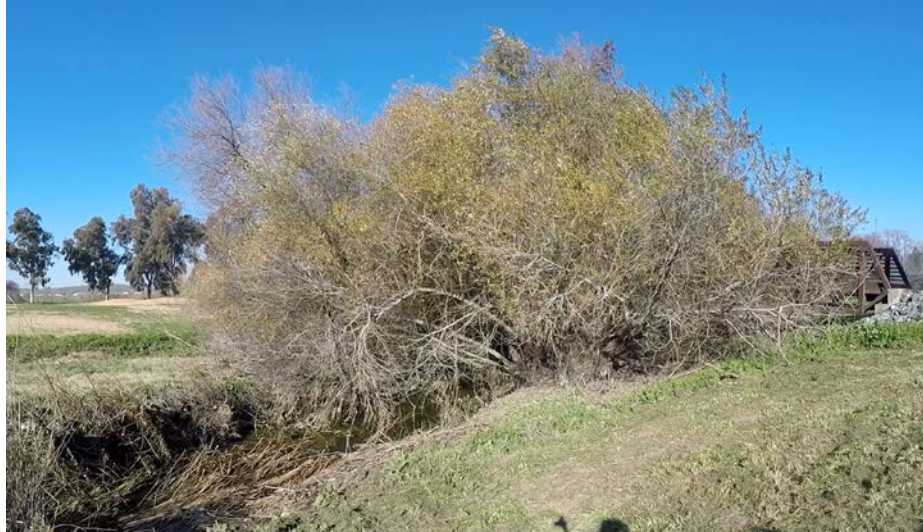
Arroyo Las Positas – Golf Course (37°41'55.38"N  
121°49'45.35"W)

- Overgrown vegetation / trees

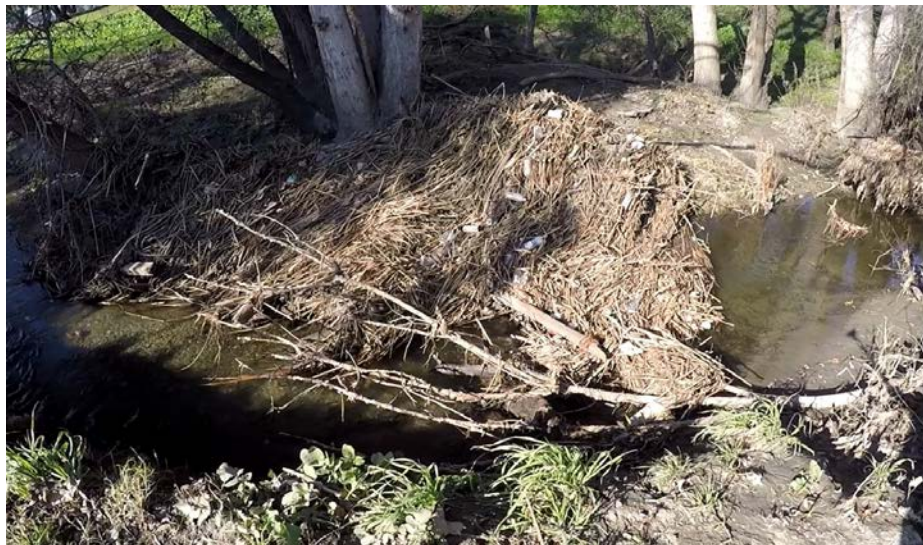
Arroyo Las Positas – Golf Course (37°41'51.10"N  
121°49'30.11"W)

- Trash and debris pile up

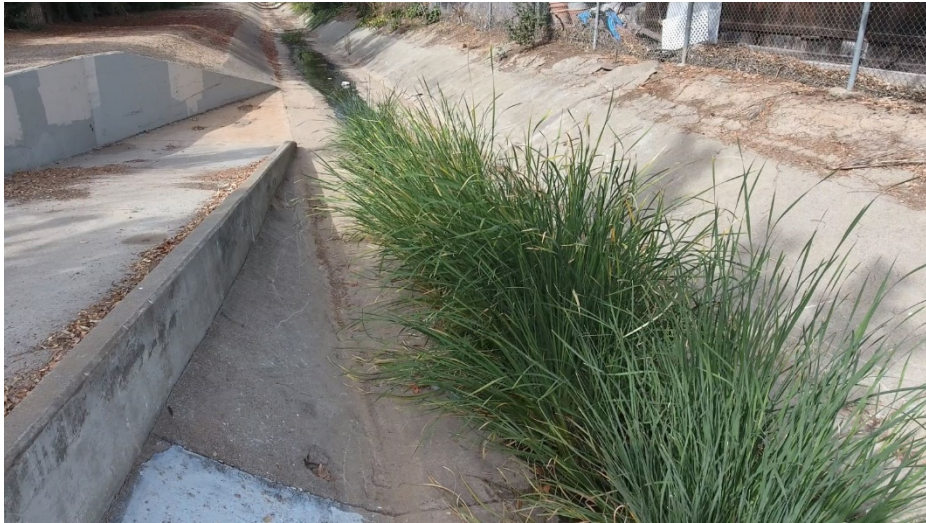
Granada Channel (37°39'56.36"N 121°47'37.34"W)

- Should not have vegetation

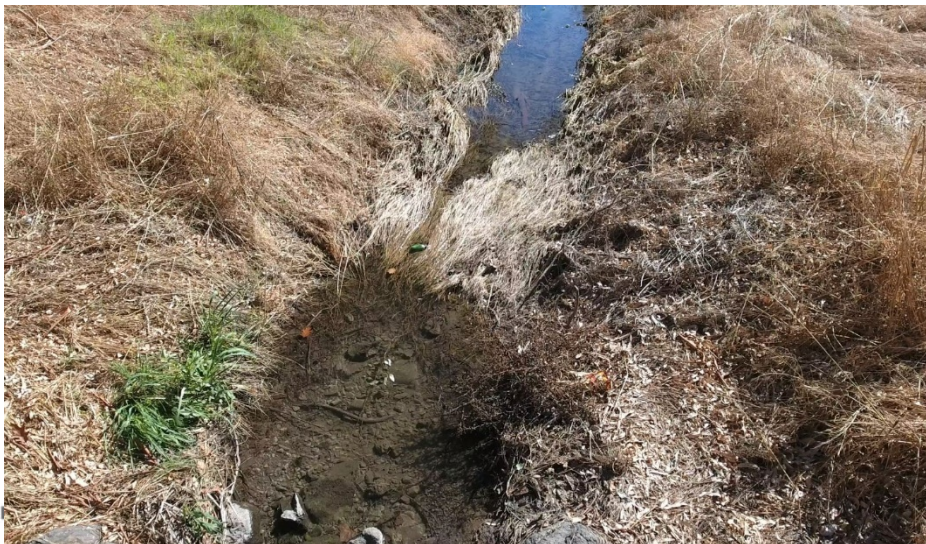
Arroyo Seco (37°40'57.47"N 121°43'18.11"W)

- Vegetation causing flow congestion

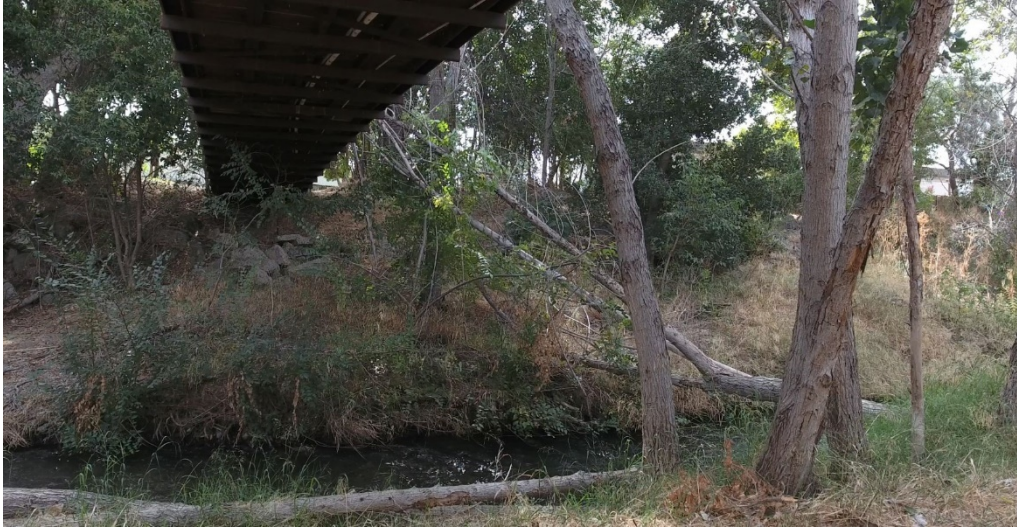
Arroyo Mocho (37°40'19.56"N 121°46'6.81"W)

- Fallen tree causing blockage

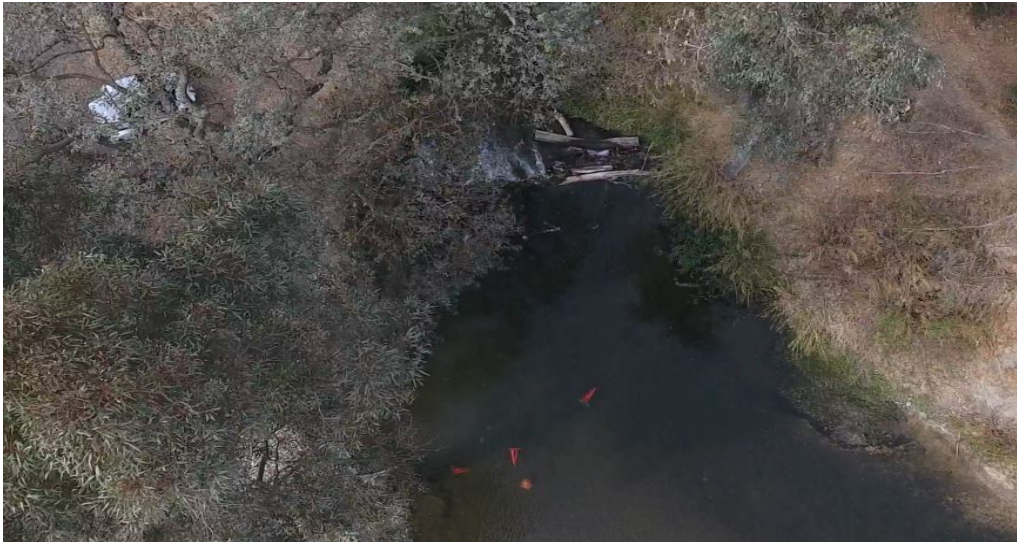
Arroyo Mocho (37°40'18.17"N 121°45'56.46"W)

- Trash (cones)
- Dead trees causing blockage
- Homeless encampment
