1 Building Management System

1.1 Background

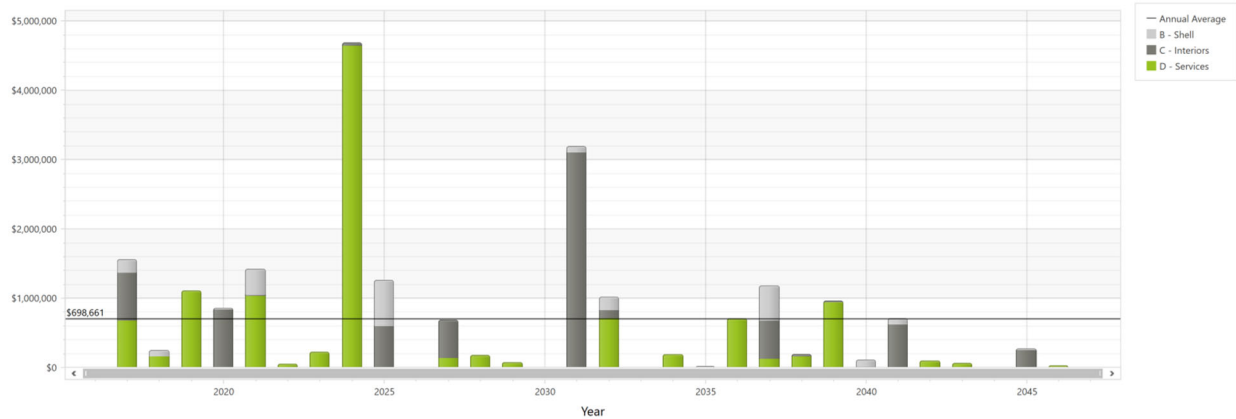
City Hall Immediate Needs

- UPS needs maintenance
- UPS battery needs replacement
- Non-rated doors need replacement
- Air conditioning units need replacement
- Condensing units need replacement
- Card readers need maintenance
- CCTV systems need maintenance
- Door hardware need maintenance
- Strobes need maintenance
- Vinyl floors and carpets need maintenance

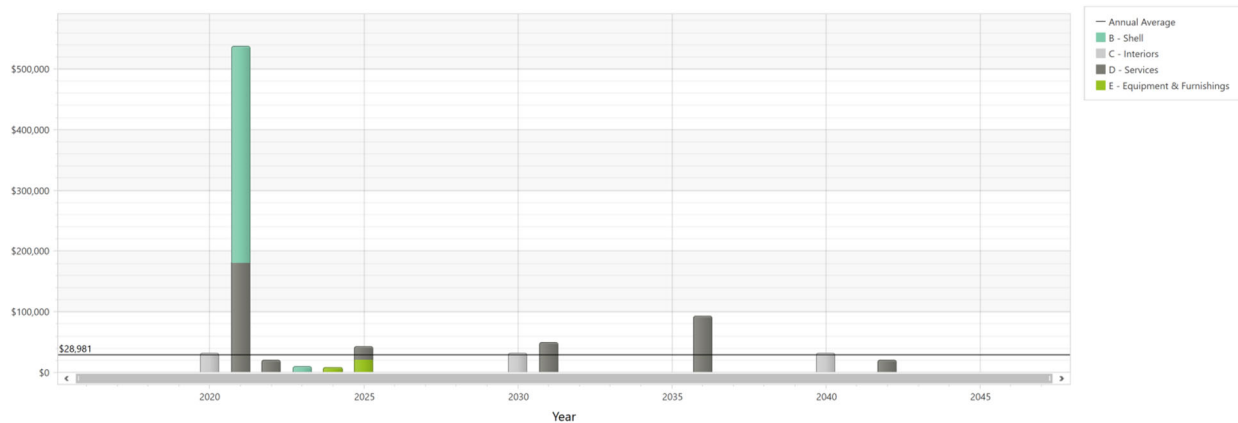
Council Chambers Immediate Needs

- Facility does not have a seismic gas shutoff valve on the gas meter as per Health and Safety Code 19180-19183.
- Verify red breaker in electrical panel for fire alarm control panel as per NFPA 72 – 10.6.5.2.3.
- Railings at stairs and ramp not compliant with CBC Chapters 10 and 11.
- Restrooms need to be verified for CBC Chapter 11 compliance.
- Water fountain not compliant.
- No emergency exit signage at main entrance.
- Verify that all P trap boots are on in the restrooms, per CBC 11B-606.5.

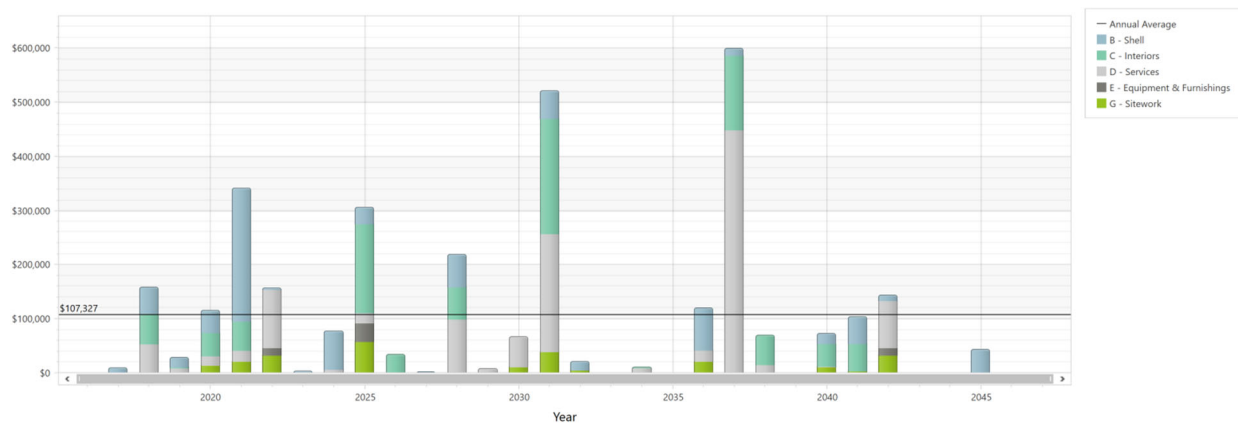
Fire Station 6 Immediate Needs

- Facility does not have a seismic gas shutoff valve on the gas meter as per Health and Safety Code 19180-19183.
- Verify that fire alarm is not required. Verify with the City Fire Marshal that a fire alarm system is not required for the building proper.

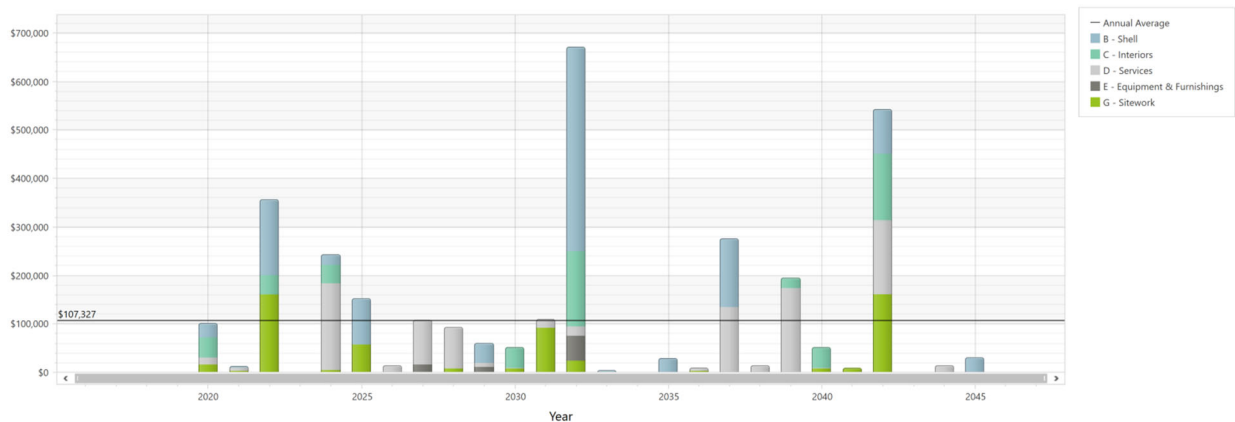
Immediate Needs

- Facility does not have a seismic gas shutoff valve on the gas meter as per Health and Safety Code 19180-19183.
- Verify that the requirements of the Health and Safety Code Section 16000-16001 which pertains to an “Essential Services” facility which a fire station falls under by state code as noted.
- Electrical room is being used for storage. Not allowed by CBC and CEC.
- Water heater closet is being used for storage.
- Verify that exit signs denote correct egress from the building. Review found exit signage lacking.
- Provide panel and circuit numbers on the infrastructure units (HVAC, water heater, etc.), to better assist in maintenance or replacement.

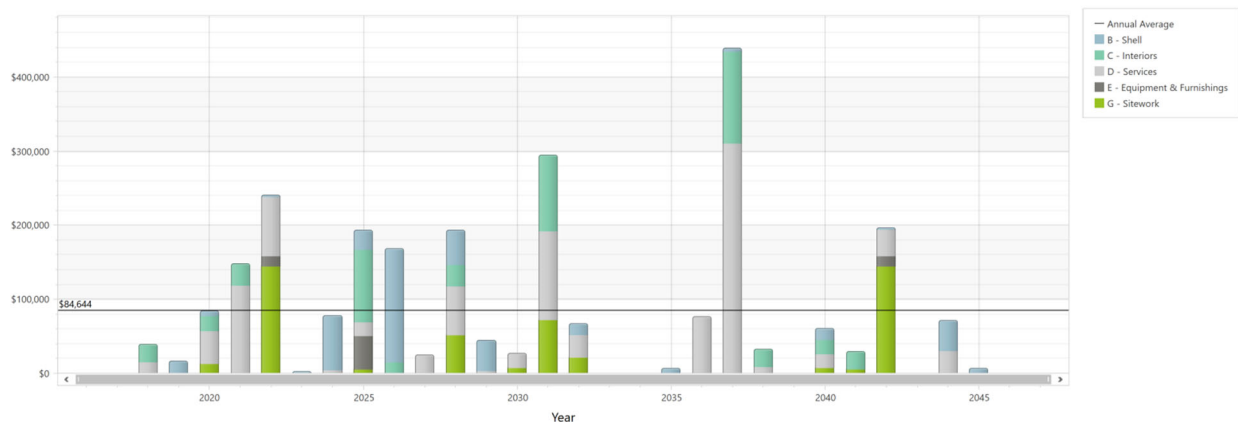
Fire Station 8 Immediate Needs

- Facility does not have a seismic gas shutoff valve on the gas meter as per Health and Safety Code 19180-19183.
- Verify that the requirements of the Health and Safety Code Section 16000-16001 which pertains to an “Essential Services” facility which a fire station falls under by state code as noted.
- Verify that fire riser breaker in the panel requires call out per NFPA 72.
- Electrical room is being used for storage. Not allowed by CBC and CEC.
- Exposed Fluorescent bulbs found without cover or cage.
- Water heater leaking.
- Service Area (washer/Dryer Location) has drywall damage.
- Maintenance required on gravel roof.
- Provide panel and circuit numbers on the infrastructure units (HVAC, water heater, etc.), to better assist in maintenance or replacement.

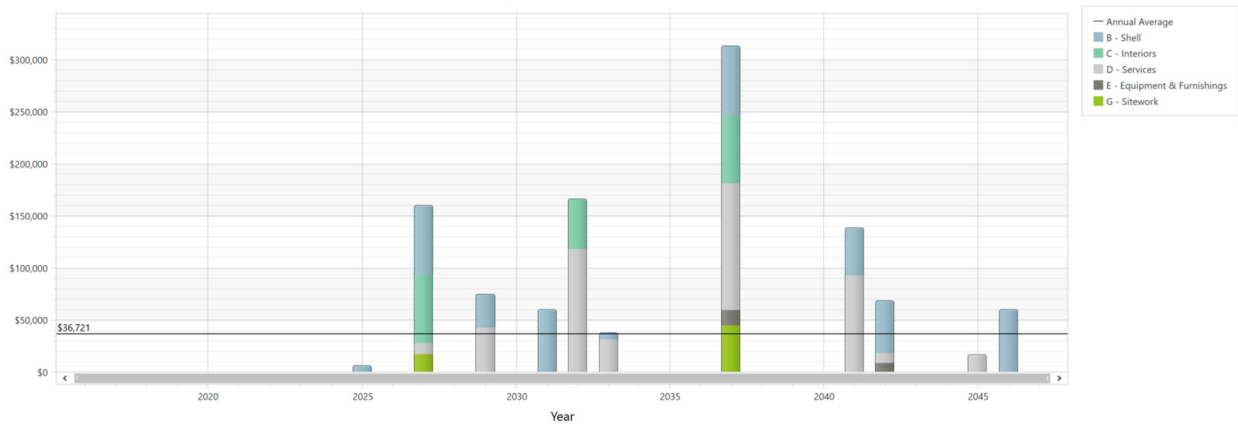
Fire Station 9 Immediate Needs

- Verify red breaker in electrical panel for fire alarm control panel as per NFPA 72 – 10.6.5.2.3.
- Peeling concrete stain in dining area.
- Storage around fire sprinkler standpipe.

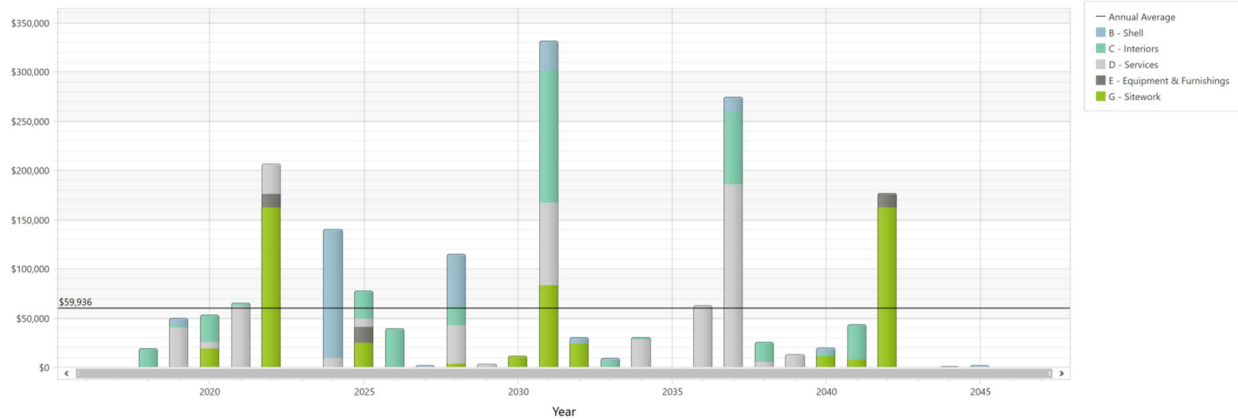
Fire Station 10 Immediate Needs

- Facility does not have a seismic gas shutoff valve on the gas meter as per Health and Safety Code 19180-19183.
- Verify that fire alarm/fire alarm system is not required for the building proper.
- Verify red breaker in electrical panel for fire alarm control panel as per NFPA 72 – 10.6.5.2.3.
- Provide panel and circuit numbers on the infrastructure units (HVAC, water heater, etc.), to better assist in maintenance or replacement.

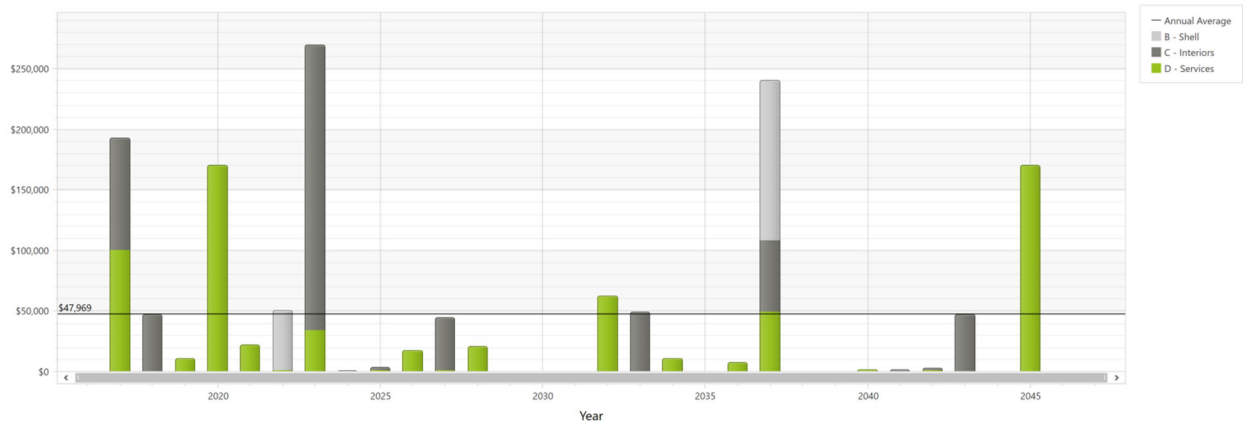
MSC Building 1 Immediate Needs

- Electrical Room #426 dedicated 24/7 Cooling needs replacement
- Fire alarm panel needs replacement and pull stations need maintenance
- Pipe mounted pump needs replacement
- Carpet and ceramic tile walls need maintenance
- Door hardware
- Light fixtures
- Thermostats

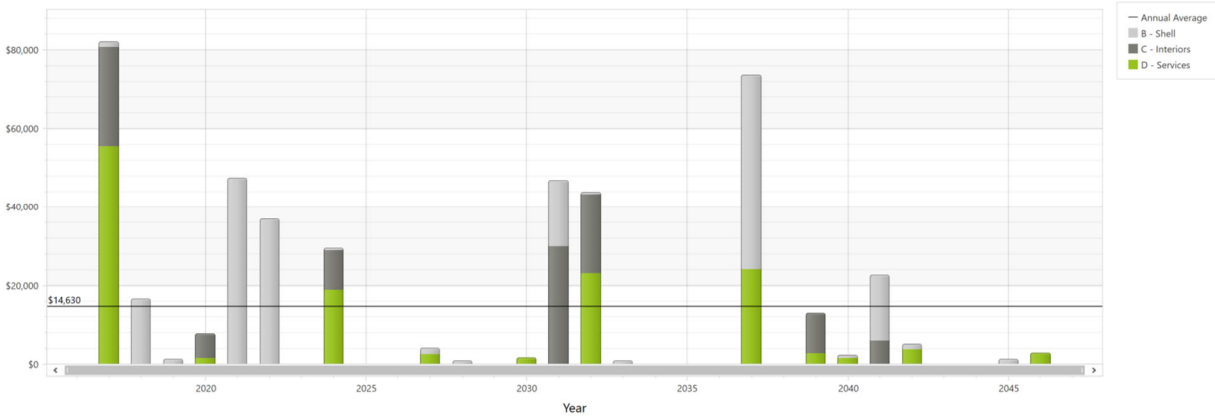
MSC Building 2 Immediate Needs

- Air conditioning unit needs replacement
- Radiant gas heaters need replacement
- Security alarm panels need replacement
- Emergency lighting fixtures need replacement
- Metal door and door hardware need maintenance
- Fluorescent light fixtures need maintenance
- Thermostat needs maintenance

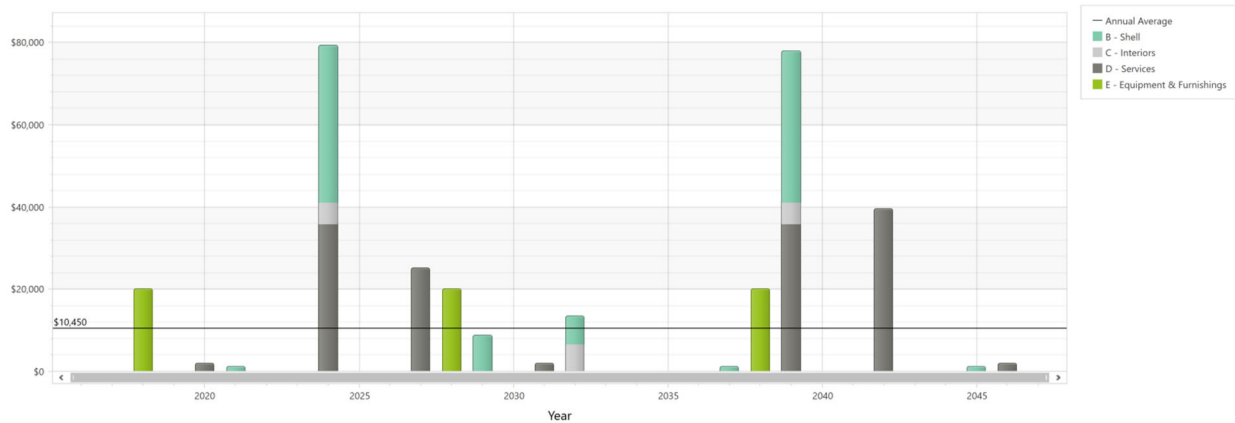
MSC Building 3 Immediate Needs

- No seismic restraints on shelving.

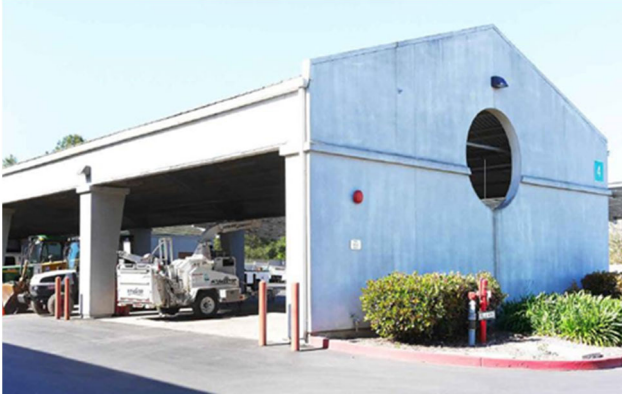
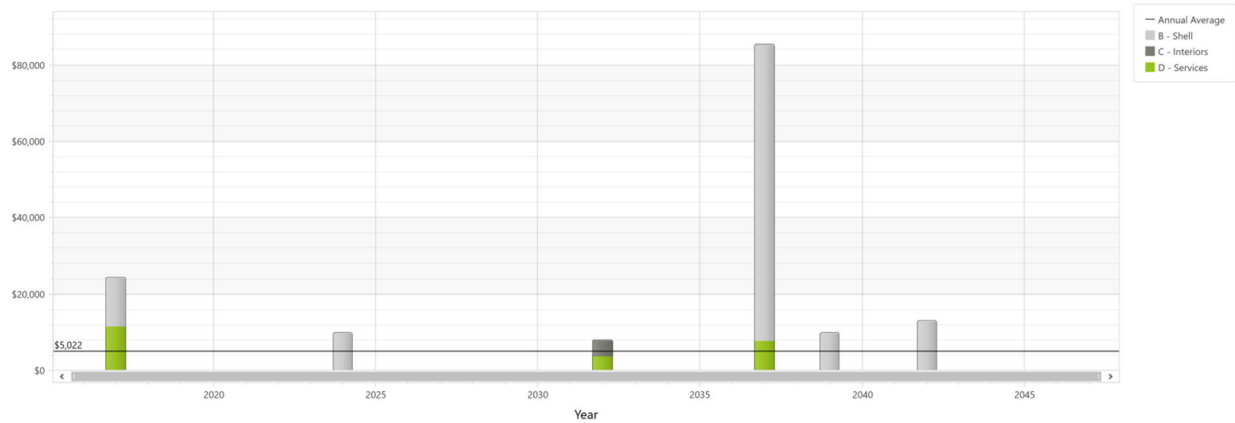
MSC Covered Parking Building 4 (Essential Facility/Core City Service)

MSC Building 4 Immediate Needs

- Time controls need maintenance
- Light fixtures need maintenance

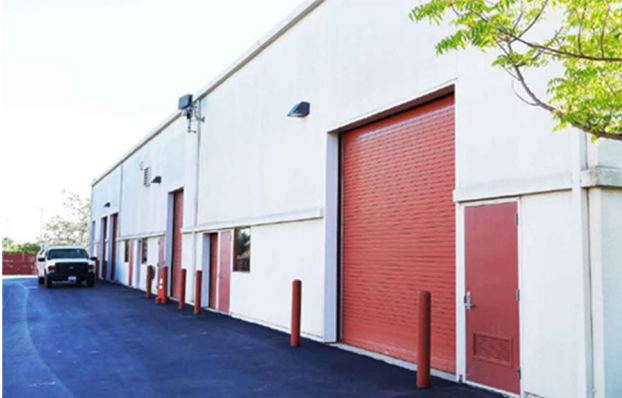
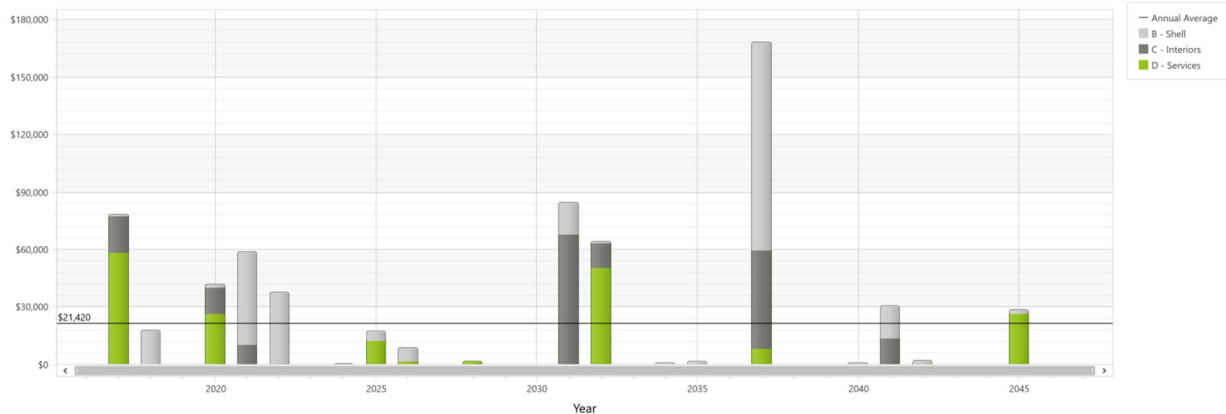
MSC Shop Building 5 (Essential Facility/Core City Service)

MSC Building 5 Immediate Needs

- Commercial heat pump needs replacement
- Exhaust fan needs replacement
- Radiant gas heaters need replacement
- Air compressor need replacement
- Light fixtures need maintenance
- Door hardware needs maintenance
- Metal door need maintenance
- Manual rollup door with man door needs maintenance

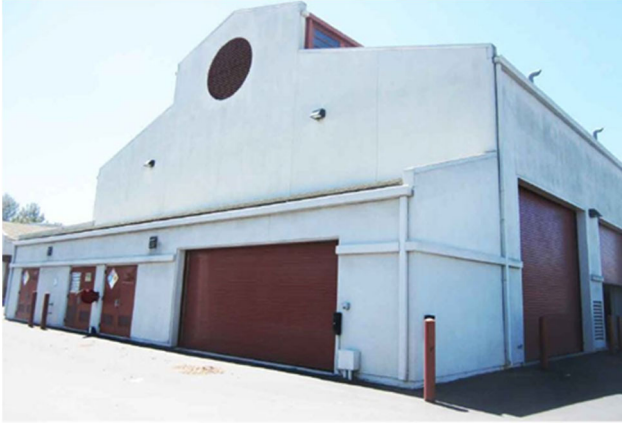
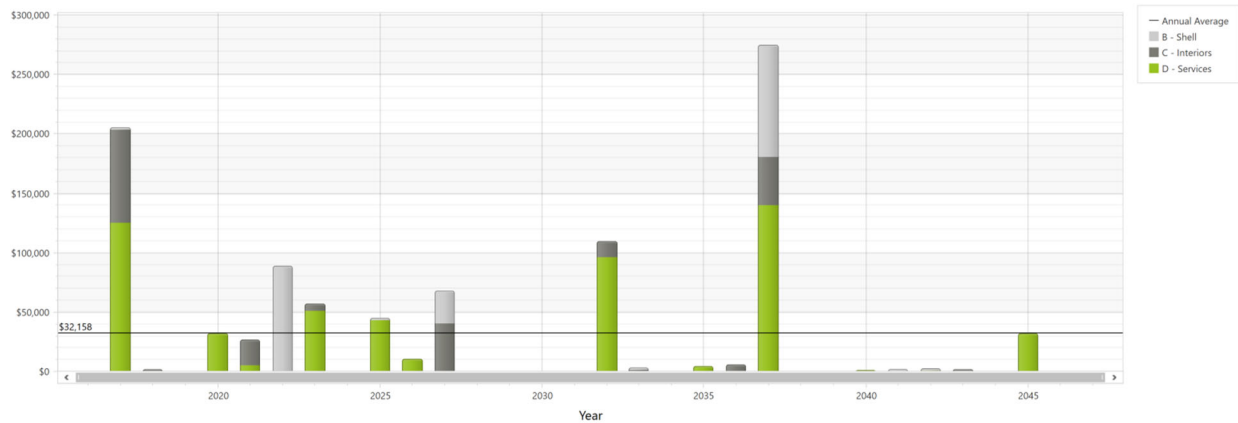
MSC Shop Building 6 (Essential Facility/Core City Service)

MSC Building 6 Immediate Needs

- Air compressor needs replacement
- Heat pump needs replacement
- Interior finishes need maintenance – plywood walls, carpet, tile
- Axial fan need maintenance
- Door hardware needs maintenance
- Light fixtures need maintenance
- Radiant gas heater needs maintenance

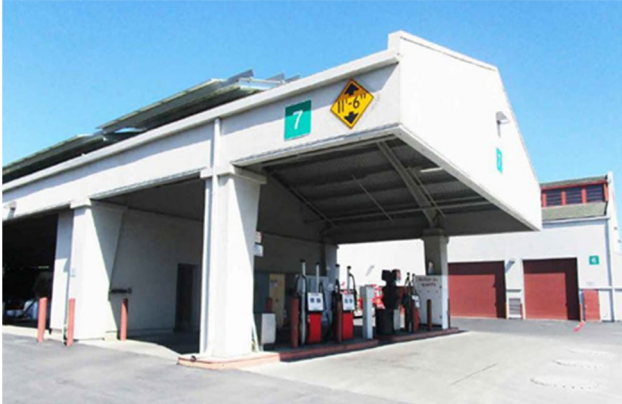
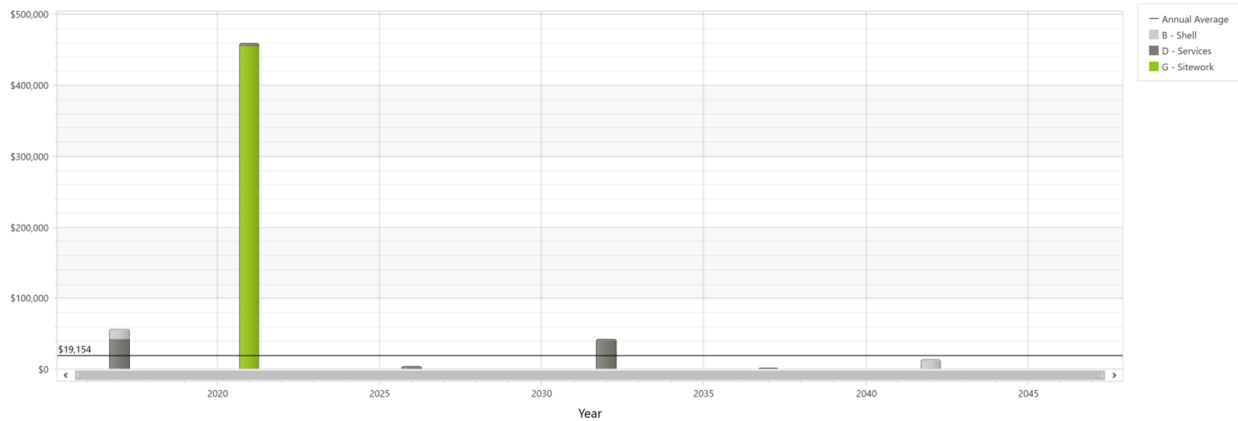
MSC Covered Parking Building 7 (Essential Facility/Core City Service)

MSC Building 7 Immediate Needs

- Solar Photovoltaic Inverters need replacement
- Air Compressor Tank needs replacement
- Door hardware needs maintenance
- Strobes need maintenance

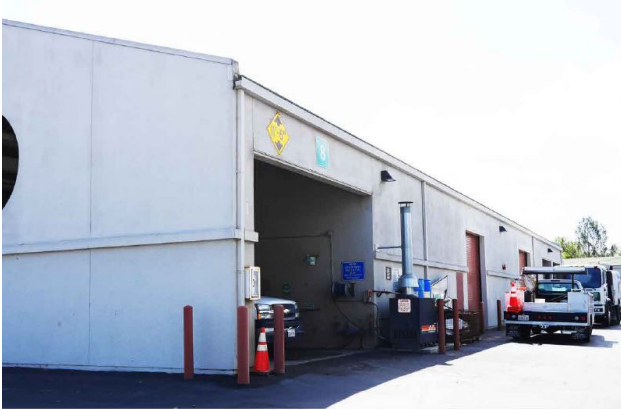
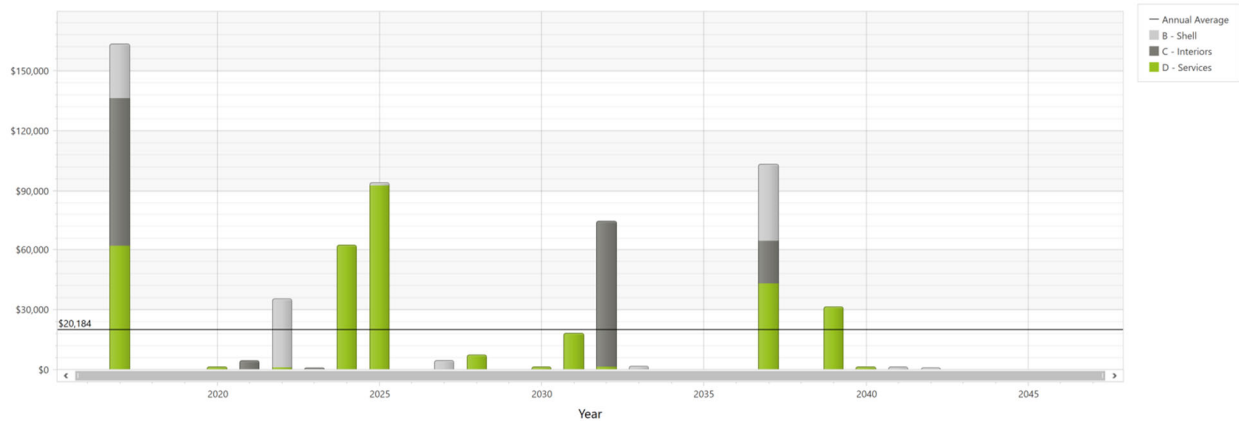
MSC Shop Building 8 (Essential Facility/Core City Service)

MSC Building 8 Immediate Needs

- Air Compressor needs replacement
- Clarifier needs replacement
- Interior walls need maintenance
- Axial fans need maintenance
- Metal door and door hardware need replacement
- Light fixtures need maintenance
- Thermostat needs maintenance

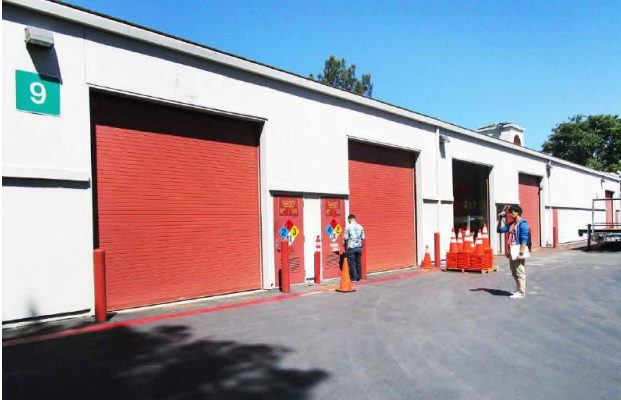
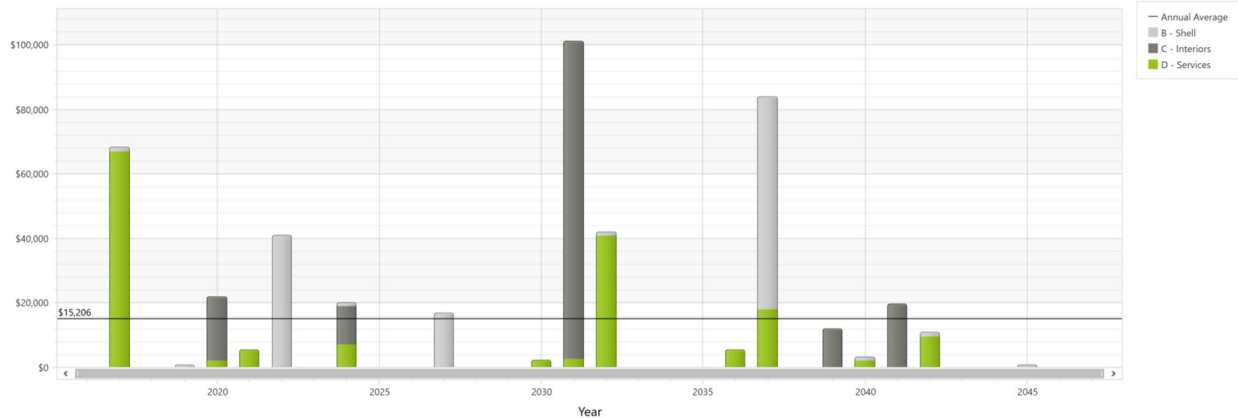
MSC Storage Building 9 (Essential Facility/Core City Service)

MSC Building 9 Immediate Needs

- Air Compressor needs replacement
- Emergency Light Fixtures and Illuminated Exit Signs need replacement
- Security Alarm Panels need replacement
- Door Hardware need maintenance

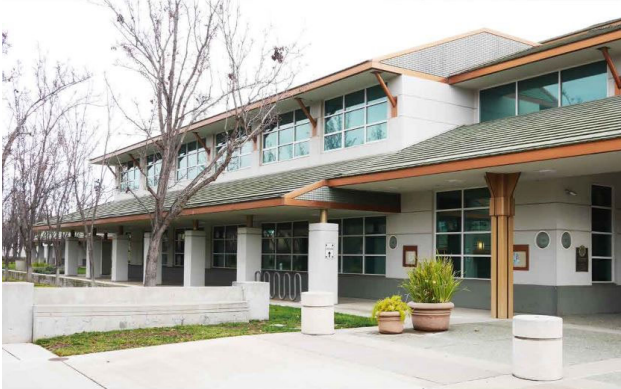
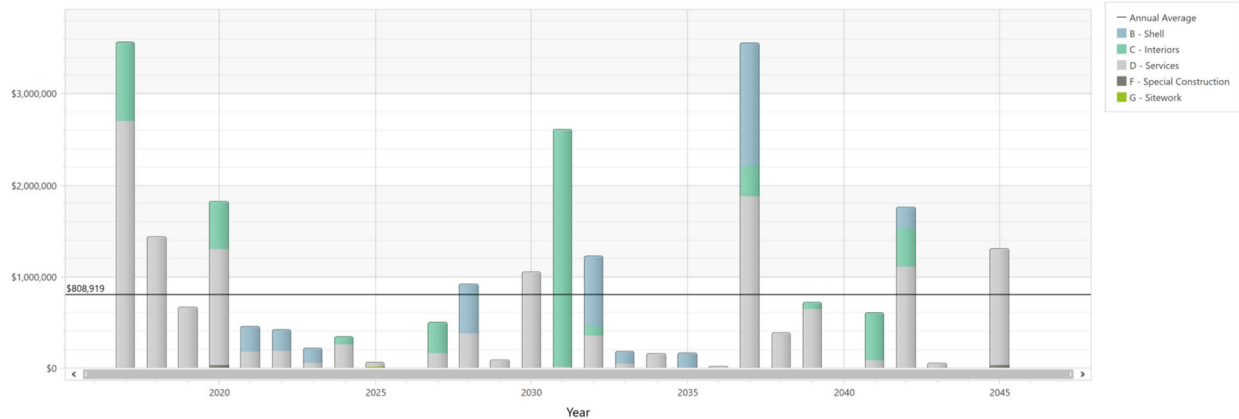
Police Facilities (Essential Facility/Core City Service)

Police Facilities Immediate Needs

- UPS Batteries
- Built-up Gravel Roof
- Chiller 01 and 02
- Emergency Generator
- Pumps
- A/C Condensing Units
- Hydraulic Elevator
- Vacuum Air Cleaner
- Air Compressor
- Elastomeric Membrane Flat Roof

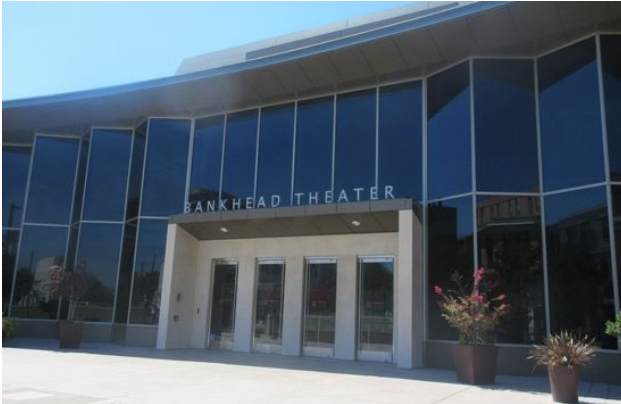
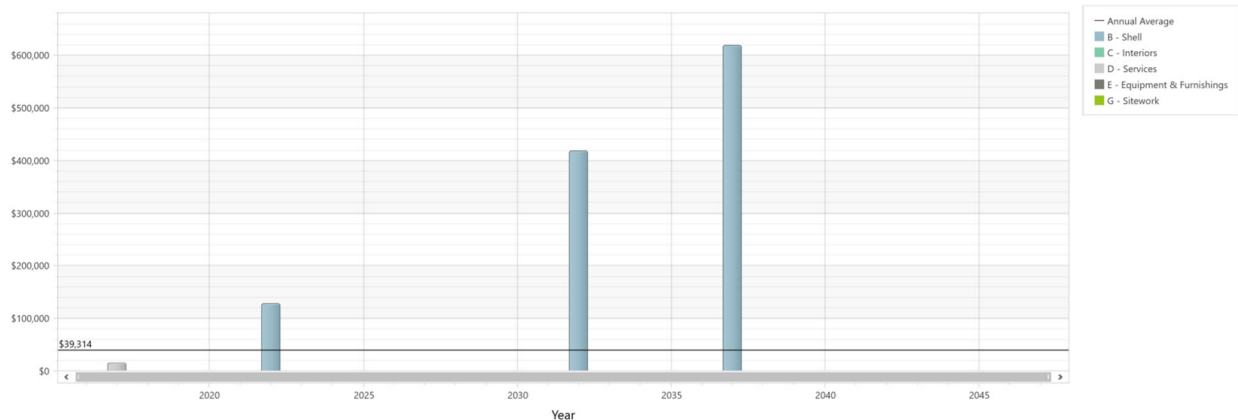
Bankhead Theater (Specific Enrichment Facility/General Usage)

Bankhead Theater Immediate Needs

- Roof needs some maintenance, basic cleaning and periodic review.
- Single ply on roof parapet is bubbling. This should be reviewed by the manufacturer to see if this is a possible issue and should be repaired.

- Walking bridges should be looked into for going over roof ducting. Portable ladders are being used to get up on ducting, then ducting is used as main pathway to get to the other side. This looks to be a safety hazard and possibly damaging the ducting.

- Walking pads should be installed on heavily used paths to units to minimize damage to roofing surface.
- A roof ladder at the roof access hatches should be installed. Roof access requires hazardous usage of an extension ladder over 15 feet on a landing in an exit stairwell to gain access to the roof.

- Skylights need to be cleaned.
- Some of the line sets on the roof HVAC units are damaged and are in need of repair.
- Electrical rooms are being used for storage. Not allowed by CBC and CEC.

- Storage found in basement rated corridor. Could be possible issue with fire marshal.
- Wood raised platform at the orchestra pit and the trap door enclosure at the stage needs to be reviewed

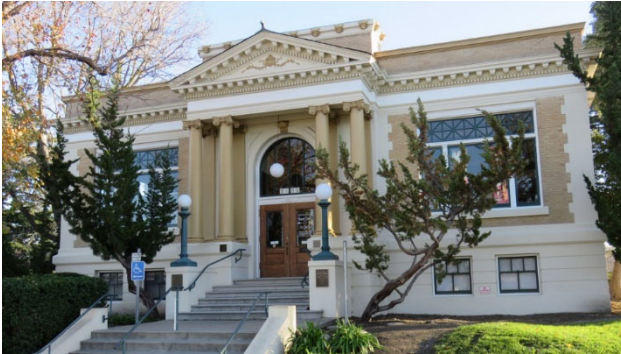
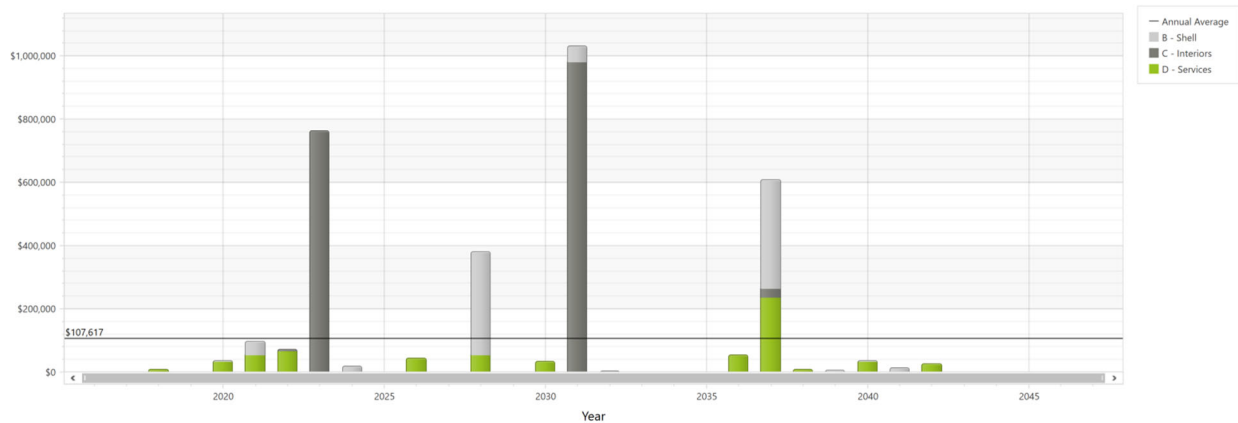
Carnegie Library (Specific Enrichment Facility/General Usage)

Carnegie Library Immediate Needs

- Facility does not have a seismic gas shutoff valve on the gas meter as per Health and Safety Code 19180-19183.
- Furnace looks in need of repair or replacement.

- No fire alarm or fire sprinklers.
- Restrooms not compliant with CBC Chapter 11.
- Lights in restrooms need repair or replacement.
- Basement interior ramp not compliant with CBC.

- Building requires additional ADA and way finding signage.
- Spline tile system in the basement in some areas is coming down and is in need of replacement or maintenance.

- Area under the stairs is being used for storage, not allowed by CBC.
- Water damage found at hardlid ceiling in interior stairwell.
- Main level stairway, interior, does not provide accessibility. Needs review.

- Window air conditioning units need to be reviewed for maintenance or replaced.
- Exterior stairs and handrail next to chairlift not compliant with CBC. Also do not meet historical nature of

- Issues with ramp to chairlift/stairs. Handrail protrusion could be a hazard.
- Basement level access next to chairlift not ADA compliant.

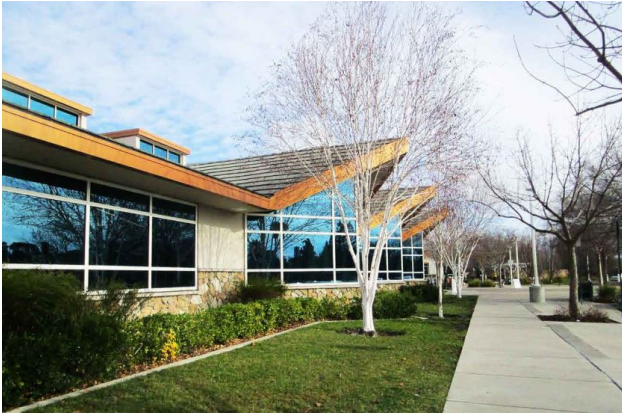
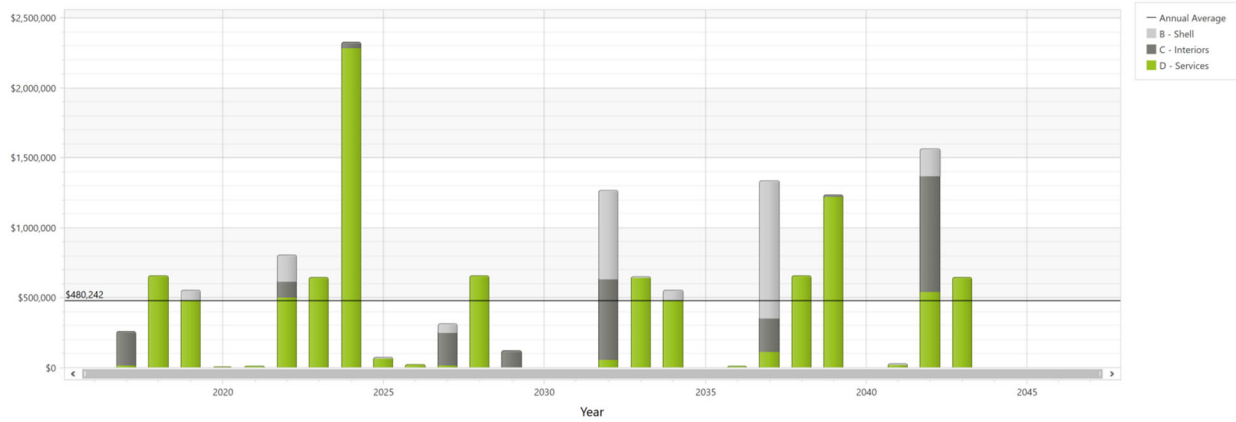
Civic Center Library (Specific Enrichment Facility/General Usage)

Civic Center Library Immediate Needs

- Dormer Roof
- Gas-Fired Water Heater
- Carpet

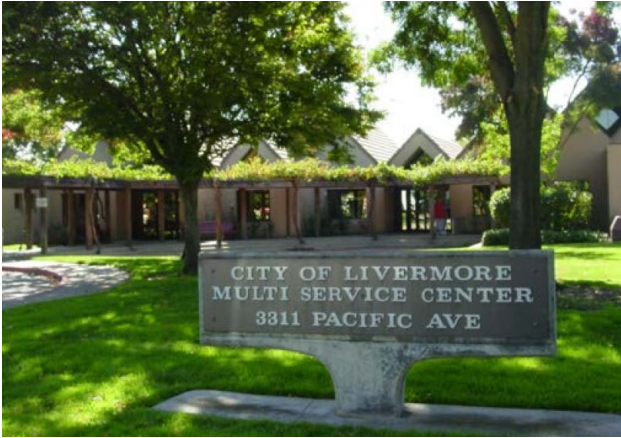
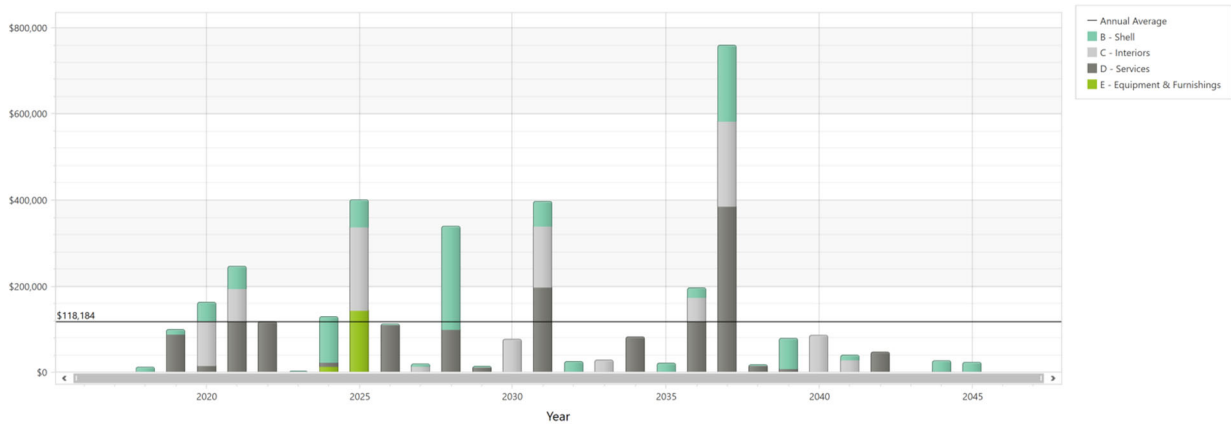
Multi Service Center (Specific Enrichment Facility/General Usage)

Multi Service Center Immediate Needs

- Verify red breaker in electrical panel for fire alarm control panel as per NFPA 72 – 10.6.5.2.3.
- Electrical room being used for storage.
- Clearances not being kept at the electrical panels per CEC.
- Trellis is in need of repair or replacement.
- Roof gutters need to be cleaned.
- Water fountain not compliant.
- Review unisex/single stall restroom door hardware for compliancy with the code. Found a deadbolt and a push button lockset. May want to go to turn “Vacancy/No Vacancy” type of unit.

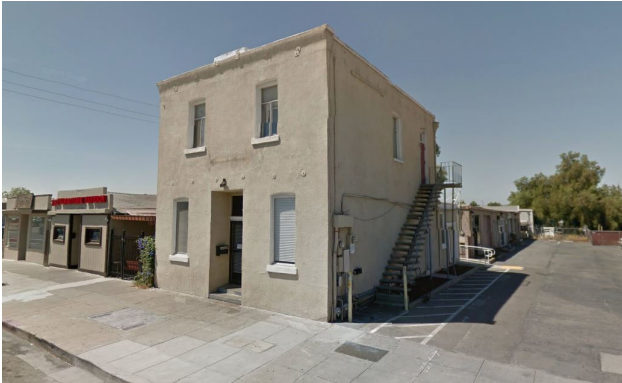
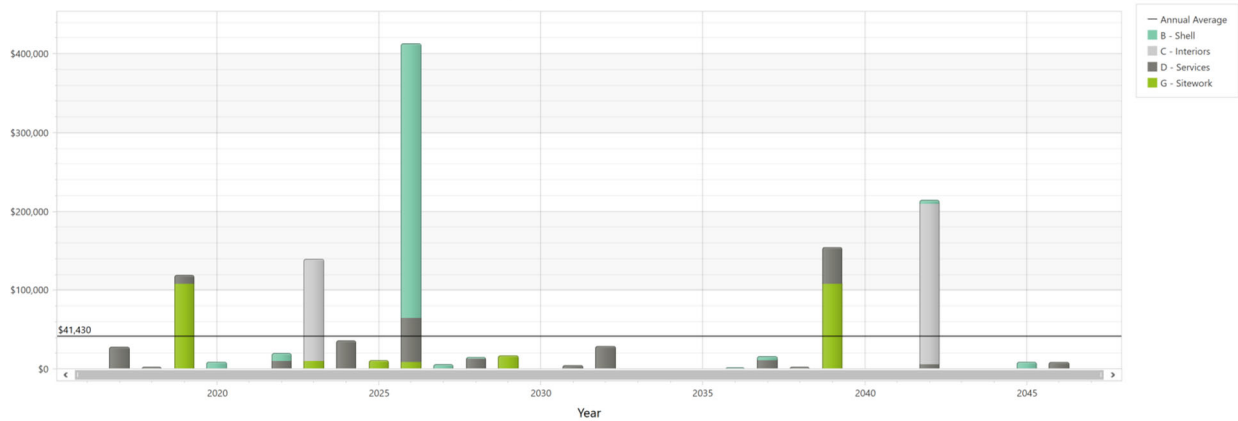
141 N Livermore Ave (Enrichment Facility/Specific Usage)

141 N Livermore Ave Immediate Needs

- Facility does not have a seismic gas shutoff valve on the gas meter as per Health and Safety Code 19180-19183.
- Structural cracking found.
- Street entrance not accessible.
- Upper level stairs and landing not CBC compliant.
- Rear ramp, landing, and handrails not compliant with CBC.
- Parking area needs to be restriped to meet accessible parking areas and path of travel.

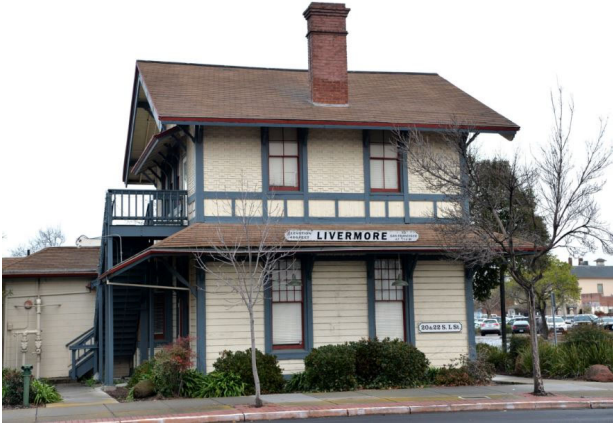
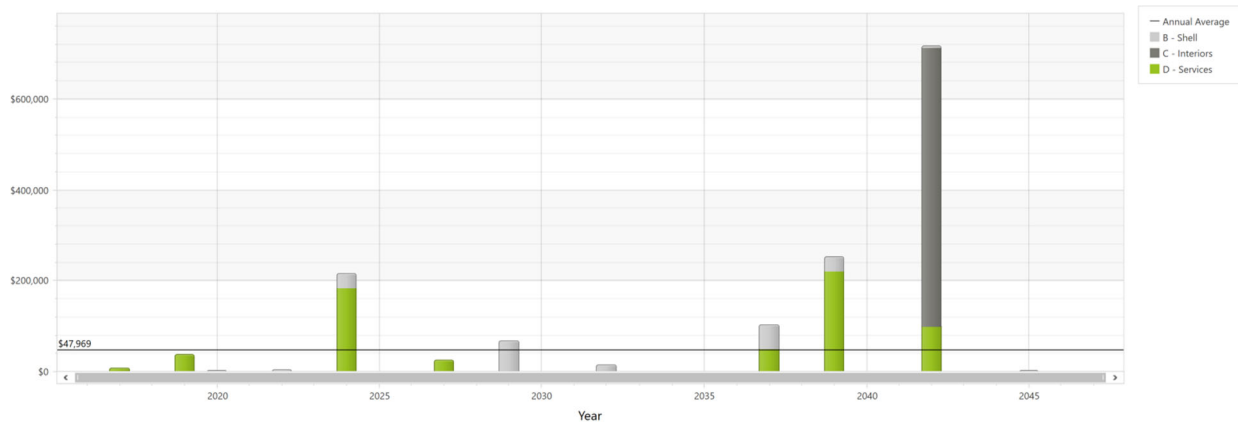
Railroad Train Depot Building (Enrichment Facility/Specific Usage)

Railroad Train Depot Building Immediate Needs

- Facility does not have a seismic gas shutoff valve on the gas meter as per Health and Safety Code 19180-19183.
- Building looks in need of painting.
- Door hardware not compliant with existing code.
- Exterior railings not compliant with existing code.
- Some dry rot found on the exterior of the building need to be replaced.
- Roof damage found at eaves.
- Foundation of building needs to be reviewed for structural integrity.
- No accessibility to upper level found.
- Stairs/handrail to upper level is not code compliant and is missing the guardrail.

- Stairs to upper level need to be repaired or replaced.
- Built up roofing needs maintenance or needs to be replaced.

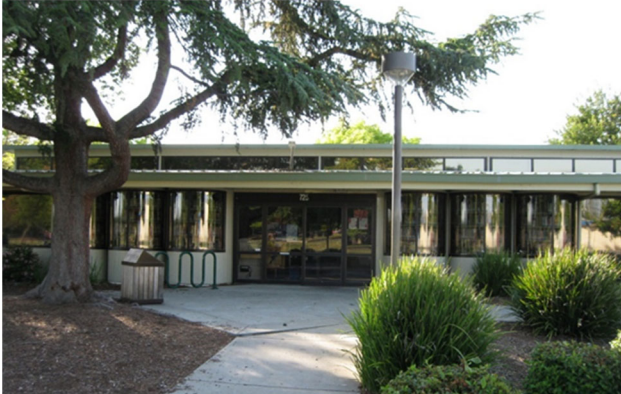
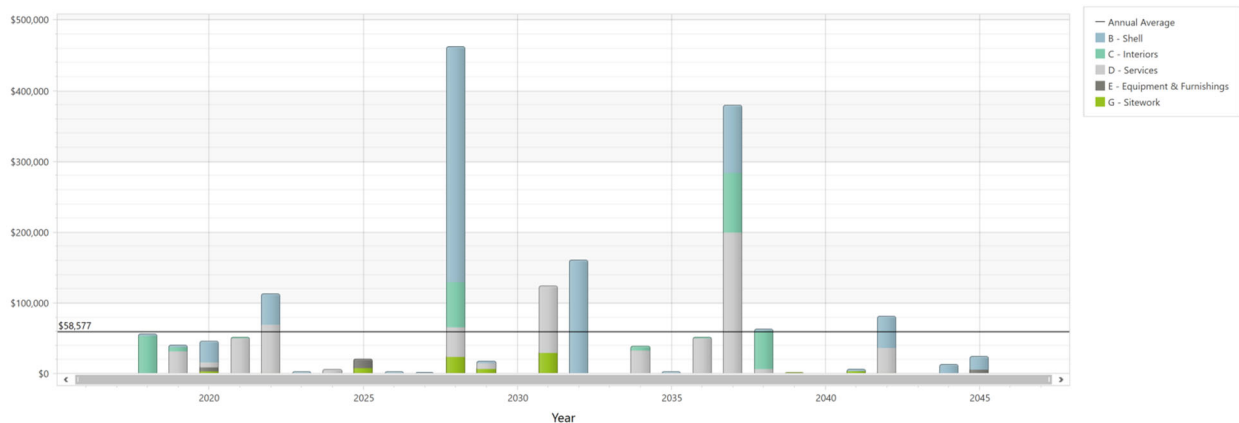
Rincon Library (Enrichment Facility/Specific Usage)

Rincon Library Immediate Needs

- Facility does not have a seismic gas shutoff valve on the gas meter.
- Verify red breaker in electrical panel for fire alarm control panel as per NFPA 72 – 10.6.5.2.3.
- Door not compliant with CBC Chapter 11.
- Water fountain not compliant.
- Electrical room being used for storage.
- May want to provide panel and circuit numbers on the HVAC units.
- Verify that countertop height in restrooms meet CBC Chapter 11 requirements.
- Signage needs to be uniform and updated.
- Trees need to be trimmed and gutters cleaned.

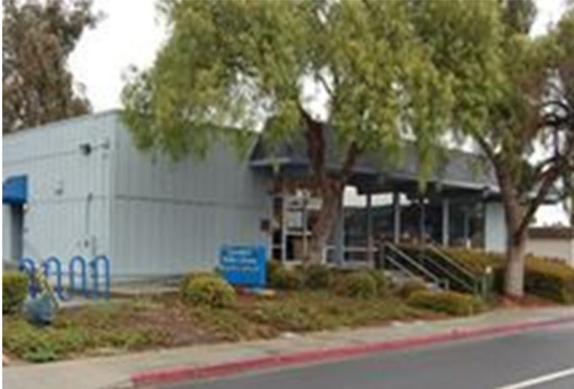
Springtown Library (Enrichment Facility/Specific Usage)

Springtown Library Immediate Needs

- Facility does not have a seismic gas shutoff valve on the gas meter
- Verify red breaker in electrical panel for fire alarm control panel as per NFPA 72 – 10.6.5.2.3.
- Verify that roof ladder is in compliance with CALOSHA.
- Area around access ladder is being used for storage.
- Roof HVAC supply duct needs to be insulated.
- Verify clearances in restrooms.
- Siding damage found in various locations on the building.
- Verify that the railing for the stairs meet CBC requirements.
- Electrical panel looks to need rebuilding.
- Storage in front of electrical panel is not compliant with clearances noted within CEC.

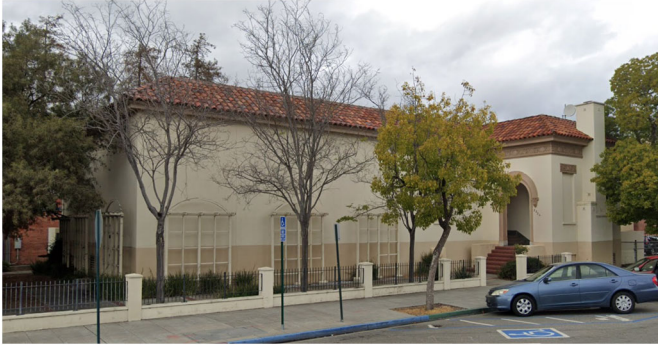
Southern Bell Building (Enrichment Facility/Specific Usage)

- Found trouble alarms on the fire alarm control panel.
- Verify red breaker in electrical panel for fire alarm control panel as per NFPA 72 – 10.6.5.2.3.

- Structural cracks found in exterior wall.
- No accessible entry.
- Exit gate on street does not have egress panic hardware. May be required by code.
- Main entrance needs handrails.

- Roof ladders very unstable and need to be brought up to OSHA requirements.
- Lower and upper roofs need maintenance or replacement. Replacement should be in a maximum 5 years.

- Middle roof needs maintenance.
- Maintenance need on mansard roof mission tiles.
- Verify when filters have been changed on the building units. Looked in need of replacement.

- Provide panel and circuit numbers on the infrastructure units (HVAC, water heater, etc.), to better assist in maintenance or replacement.
- Electrical panels found to not have required clearances as per CEC.
