1 Wall Management System

1.1 Background

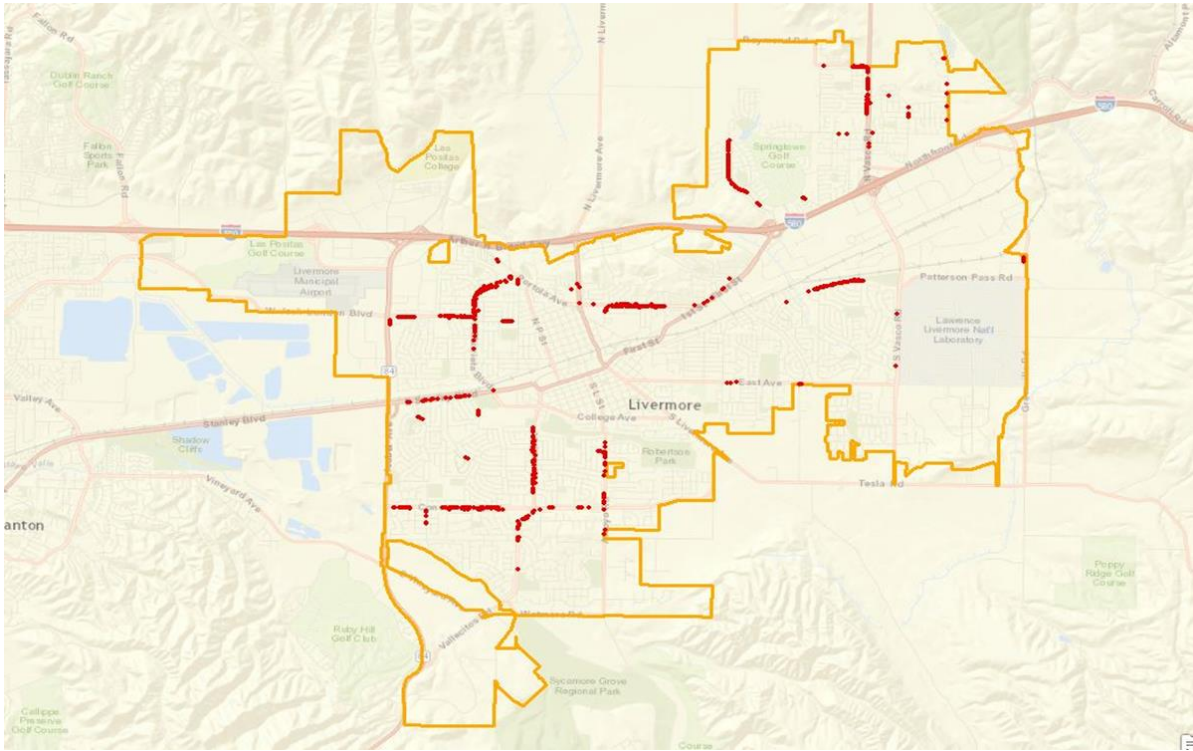
Figure 1-13 Wall Fault Locations

Condition is one of the best indicators for estimation of immediate and/or future rehabilitation and replacement work. During the asset inventory field visits, each wall was assessed for damage points along the wall. These damage points ranged from minor damage (e.g., graffiti, minor cracking) to major faults (e.g., wall leaning several degrees, major vertical/structural cracks, failed panels). A total of 841 wall fault locations (e.g., crack, bulging, leaning) were identified throughout the City. These locations are represented by the red dots on the map in the following figure.

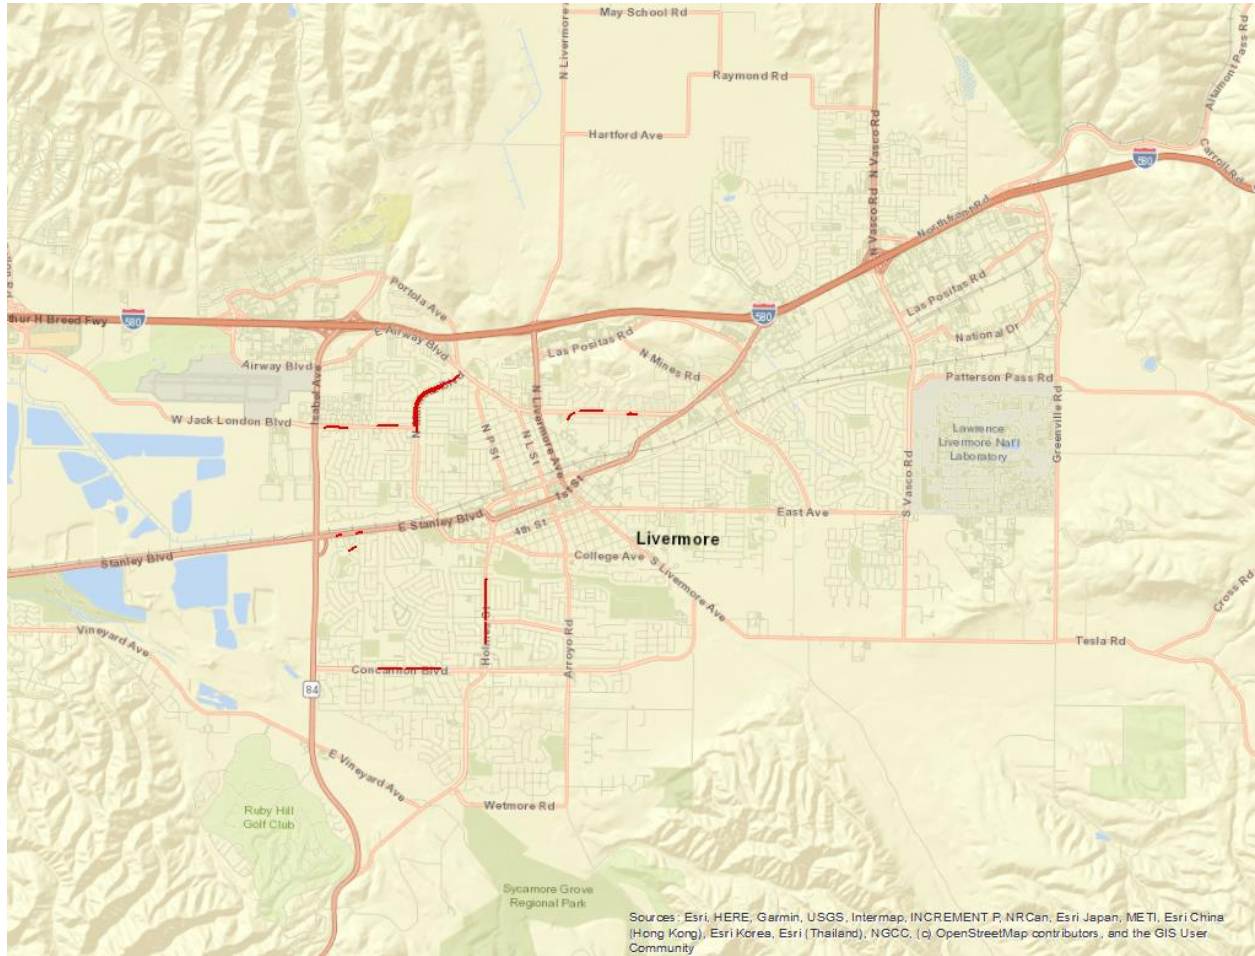
Figure 1-16 Walls in Conditions 4 or 5

Many of the walls are in good condition with condition scores of 1, 2, or 3. As shown in Table 1-3, approximately 3.2 miles of wall is in poor condition (i.e., condition score of 4 or 5). The cost to replace condition 4 and 5 walls is approximately \$15.9 million.

Figure 1-16 highlights walls that are in poor condition and will therefore need attention in the near future.

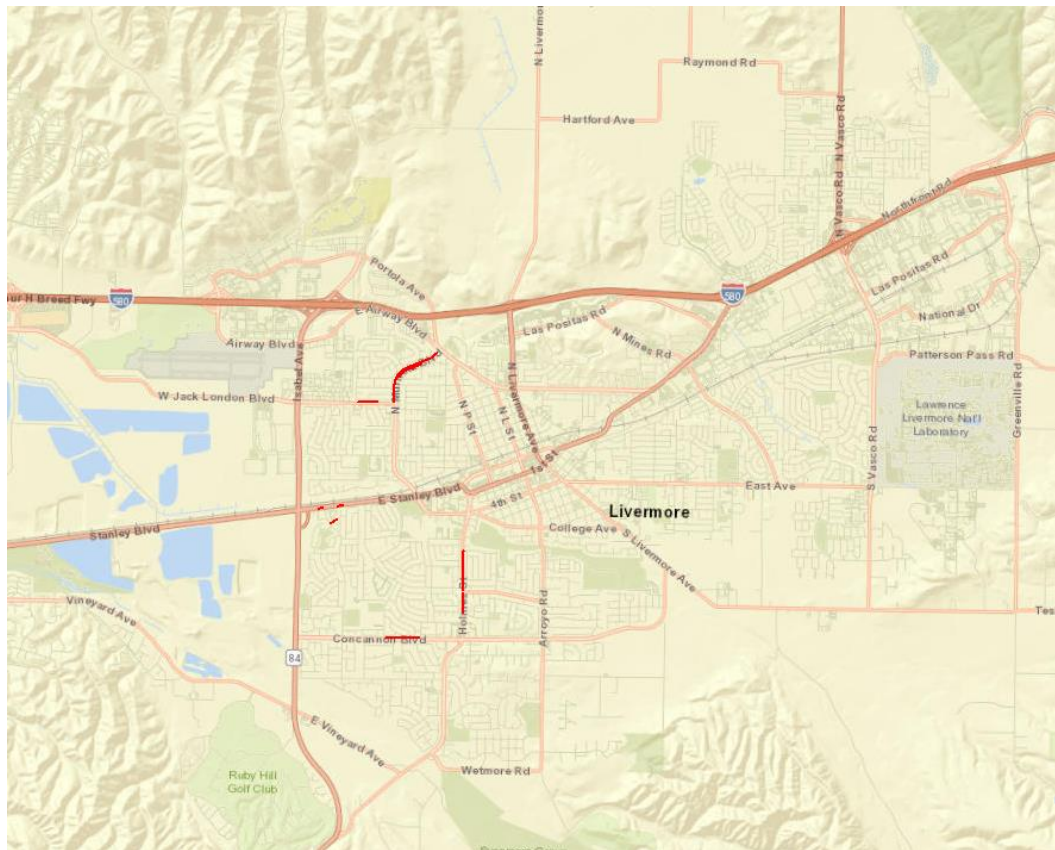
Figure 1-21 High Risk Walls Map

Figure 1-20 shows the resulting overall risk profile for the Wall Management System. This profile incorporates both the PoF and CoF scores to prioritize the walls. The assets in the red zone of the risk matrix are the highest risk assets that have both a high probability and high consequence of failure. Walls with a risk score of 4 and above were considered high risk. The summation of replacement cost for all high-risk walls (red zone) equated to approximately \$9.7 million. These high-risk assets consist of walls in poor condition along high pedestrian areas, city entry points, and arterials.
