# 1 Building Management System

## 1.1 Background

### 1.1.1 What Services Do These Assets Provide?

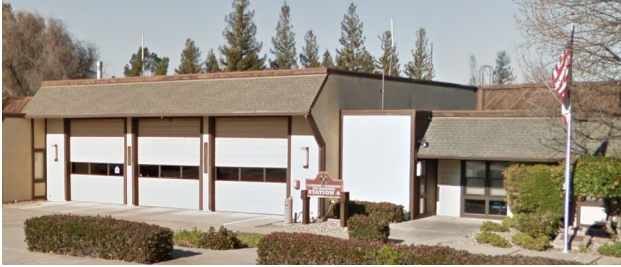
## Fire Station 6 (Essential Facility/Core City Service)

- Facility does not have a seismic gas shutoff valve on the gas meter as per Health and Safety Code 19180-19183.
- Verify that fire alarm is not required. Verify with the City Fire Marshal that a fire alarm system is not required for the building proper.

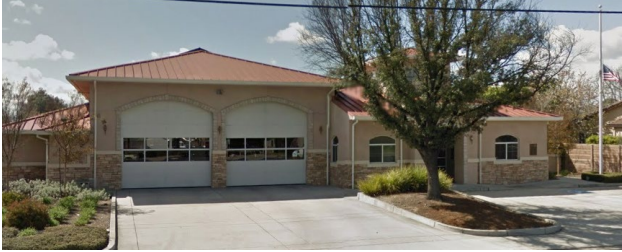
**Fire Station 7 (Essential Facility/Core City Service)**

- Facility does not have a seismic gas shutoff valve on the gas meter as per Health and Safety Code 19180-19183.
- Verify that the requirements of the Health and Safety Code Section 16000-16001 which pertains to an “Essential Services” facility which a fire station falls under by state code as noted.
- Electrical room is being used for storage. Not allowed by CBC and CEC.
- Water heater closet is being used for storage.
- Verify that exit signs denote correct egress from the building. Review found exit signage lacking.
- Provide panel and circuit numbers on the infrastructure units (HVAC, water heater, etc.), to better assist in maintenance or replacement.

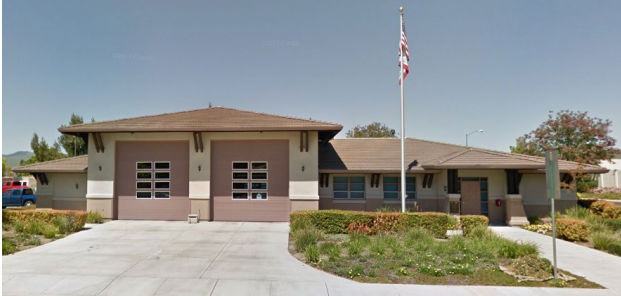
## Fire Station 8 (Essential Facility/Core City Service)

- Facility does not have a seismic gas shutoff valve on the gas meter as per Health and Safety Code 19180-19183.
- Verify that the requirements of the Health and Safety Code Section 16000-16001 which pertains to an “Essential Services” facility which a fire station falls under by state code as noted.
- Verify that fire riser breaker in the panel requires call out per NFPA 72.
- Electrical room is being used for storage. Not allowed by CBC and CEC.
- Exposed Fluorescent bulbs found without cover or cage.
- Water heater leaking.
- Service Area (washer/Dryer Location) has drywall damage.
- Maintenance required on gravel roof.
- Provide panel and circuit numbers on the infrastructure units (HVAC, water heater, etc.), to better assist in maintenance or replacement.

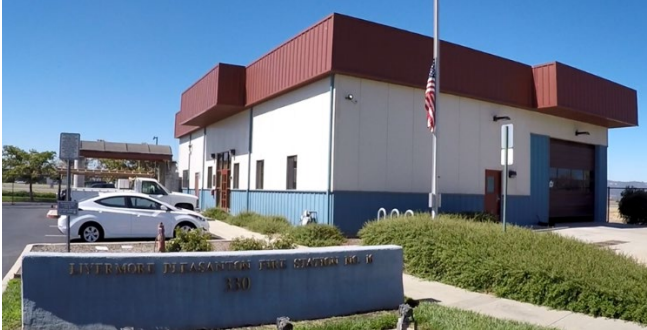
## Fire Station 10 (Essential Facility/Core City Service)

- Facility does not have a seismic gas shutoff valve on the gas meter as per Health and Safety Code 19180-19183.
- Verify that fire alarm/fire alarm system is not required for the building proper.
- Verify red breaker in electrical panel for fire alarm control panel as per NFPA 72 – 10.6.5.2.3.
- Provide panel and circuit numbers on the infrastructure units (HVAC, water heater, etc.), to better assist in maintenance or replacement.

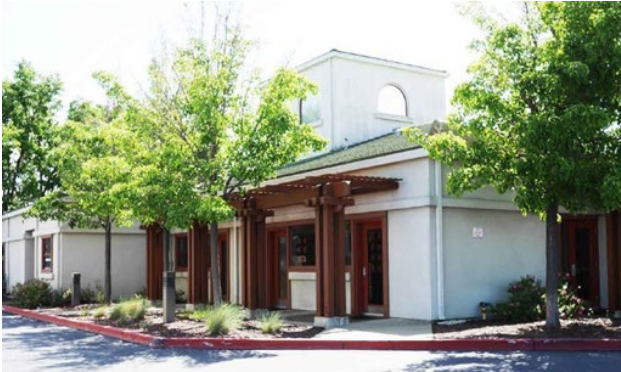
## MSC Administration Building 1 (Essential Facility/Core City Service)

- Electrical Room #426 dedicated 24/7 Cooling needs replacement
- Fire alarm panel needs replacement and pull stations need maintenance
- Pipe mounted pump needs replacement
- Carpet and ceramic tile walls need maintenance
- Door hardware
- Light fixtures
- Thermostats

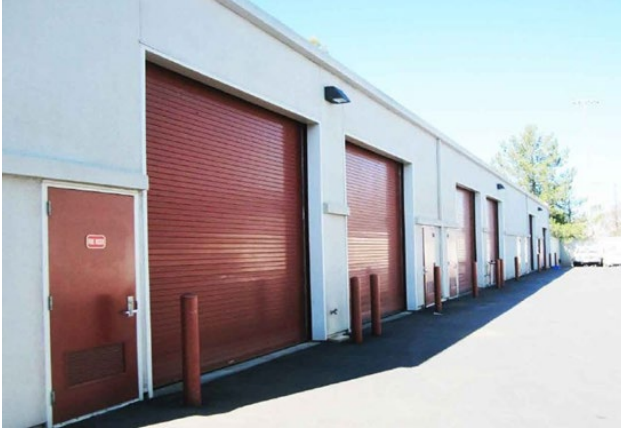
## MSC Storage Building 2 (Essential Facility/Core City Service)

- Air conditioning unit needs replacement
- Radiant gas heaters need replacement
- Security alarm panels need replacement
- Emergency lighting fixtures need replacement
- Metal door and door hardware need maintenance
- Fluorescent light fixtures need maintenance
- Thermostat needs maintenance

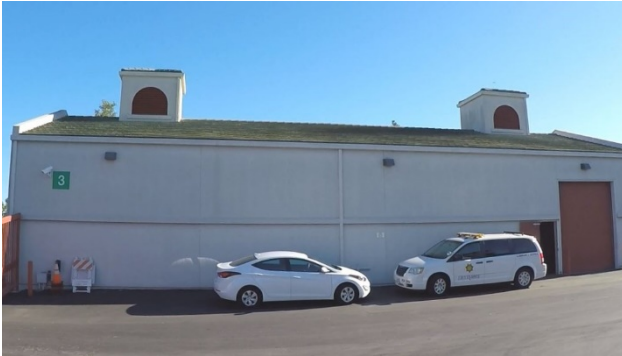
**MSC Building 3 (Essential Facility/Core City Service)**

- No seismic restraints on shelving.

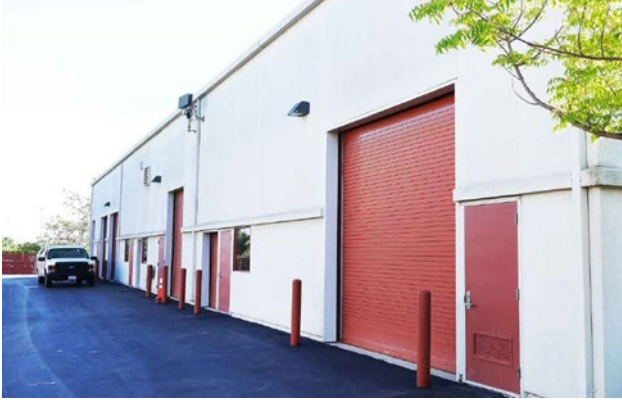
## MSC Shop Building 5 (Essential Facility/Core City Service)

- Commercial heat pump needs replacement
- Exhaust fan needs replacement
- Radiant gas heaters need replacement
- Air compressor need replacement
- Light fixtures need maintenance
- Door hardware needs maintenance
- Metal door need maintenance
- Manual rollup door with man door needs maintenance

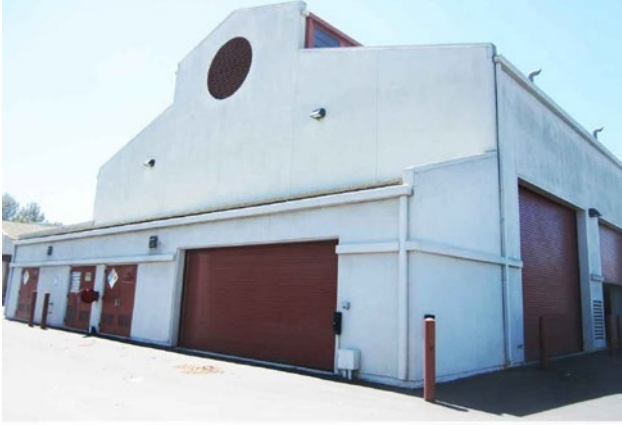
## MSC Shop Building 6 (Essential Facility/Core City Service)

- Air compressor needs replacement
- Heat pump needs replacement
- Interior finishes need maintenance – plywood walls, carpet, tile
- Axial fan need maintenance
- Door hardware needs maintenance
- Light fixtures need maintenance
- Radiant gas heater needs maintenance

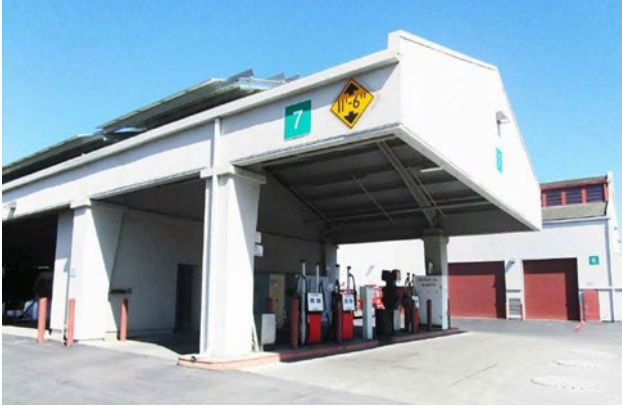
## MSC Covered Parking Building 7 (Essential Facility/Core City Service)

- Solar Photovoltaic Inverters need replacement
- Air Compressor Tank needs replacement
- Door hardware needs maintenance
- Strobes need maintenance

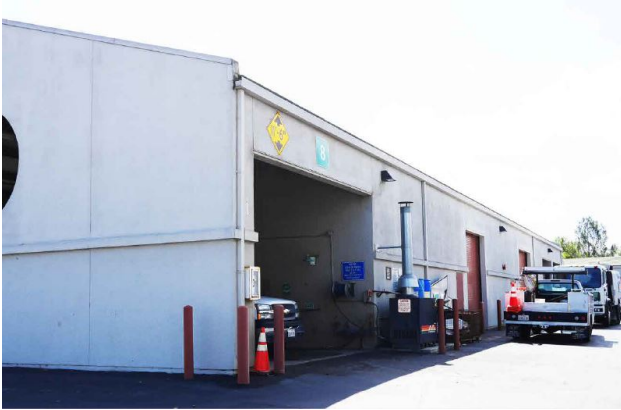
## MSC Shop Building 8 (Essential Facility/Core City Service)

- Air Compressor needs replacement
- Clarifier needs replacement
- Interior walls need maintenance
- Axial fans need maintenance
- Metal door and door hardware need replacement
- Light fixtures need maintenance
- Thermostat needs maintenance

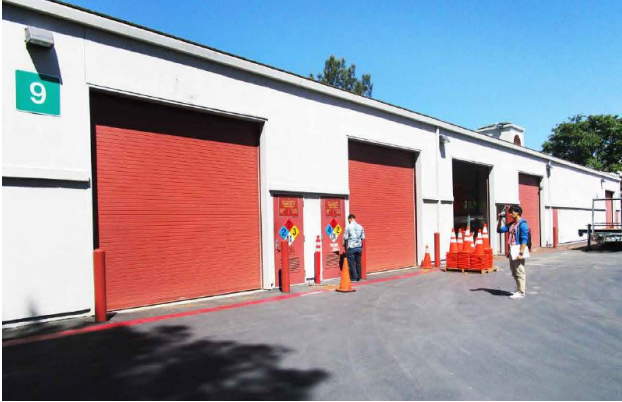
**MSC Storage Building 9 (Essential Facility/Core City Service)**

- Air Compressor needs replacement
- Emergency Light Fixtures and Illuminated Exit Signs need replacement
- Security Alarm Panels need replacement
- Door Hardware need maintenance

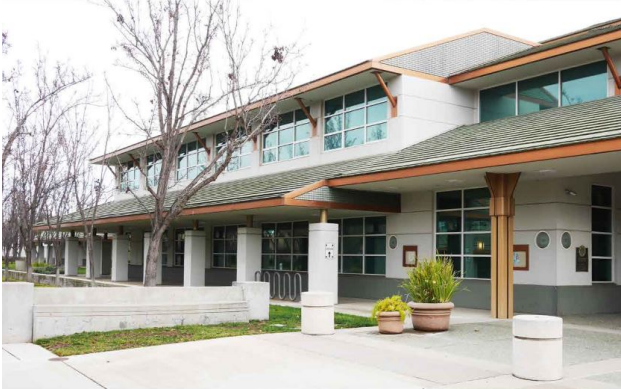
**Police Facilities (Essential Facility/Core City Service)**

- UPS Batteries
- Built-up Gravel Roof
- Chiller 01 and 02
- Emergency Generator
- Pumps
- A/C Condensing Units
- Hydraulic Elevator
- Vacuum Air Cleaner
- Air Compressor
- Elastomeric Membrane Flat Roof

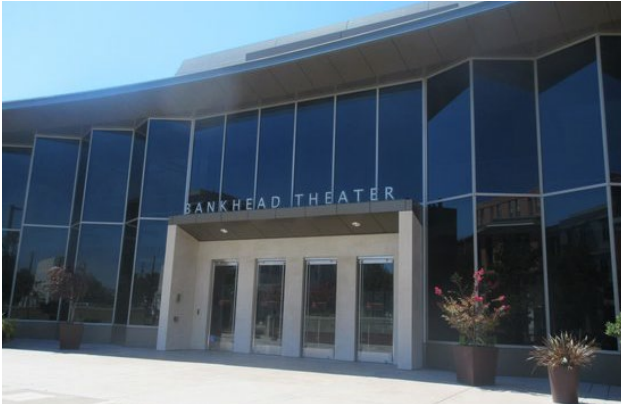
## Bankhead Theater (Specific Enrichment Facility/General Usage)

- Roof needs some maintenance, basic cleaning and periodic review.
- Single ply on roof parapet is bubbling. This should be reviewed by the manufacturer to see if this is a possible issue and should be repaired.

- Walking bridges should be looked into for going over roof ducting. Portable ladders are being used to get up on ducting, then ducting is used as main pathway to get to the other side. This looks to be a safety hazard and possibly damaging the ducting.

- Walking pads should be installed on heavily used paths to units to minimize damage to roofing surface.
- A roof ladder at the roof access hatches should be installed. Roof access requires hazardous usage of an extension ladder over 15 feet on a landing in an exit stairwell to gain access to the roof.

- Skylights need to be cleaned.
- Some of the line sets on the roof HVAC units are damaged and are in need of repair.
- Electrical rooms are being used for storage. Not allowed by CBC and CEC.

- Storage found in basement rated corridor. Could be possible issue with fire marshal.
- Wood raised platform at the orchestra pit and the trap door enclosure at the stage needs to be reviewed

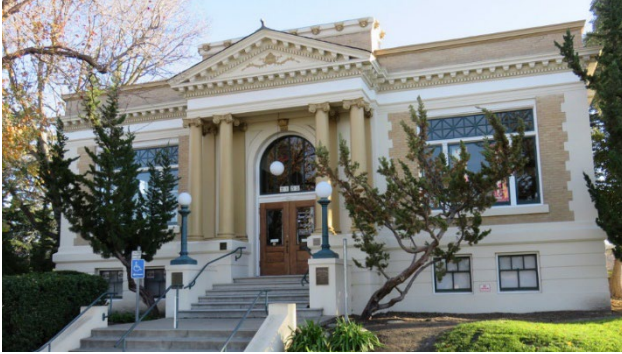
**Carnegie Library (Specific Enrichment Facility/General Usage)**

- Facility does not have a seismic gas shutoff valve on the gas meter as per Health and Safety Code 19180-19183.
- Furnace looks in need of repair or replacement.

- No fire alarm or fire sprinklers.
- Restrooms not compliant with CBC Chapter 11.
- Lights in restrooms need repair or replacement.
- Basement interior ramp not compliant with CBC.

- Building requires additional ADA and way finding signage.
- Spline tile system in the basement in some areas is coming down and is in need of replacement or maintenance.

- Area under the stairs is being used for storage, not allowed by CBC.
- Water damage found at hardlid ceiling in interior stairwell.
- Main level stairway, interior, does not provide accessibility. Needs review.

- Window air conditioning units need to be reviewed for maintenance or replaced.
- Exterior stairs and handrail next to chairlift not compliant with CBC. Also do not meet historical nature of

- Issues with ramp to chairlift/stairs. Handrail protrusion could be a hazard.
- Basement level access next to chairlift not ADA compliant.

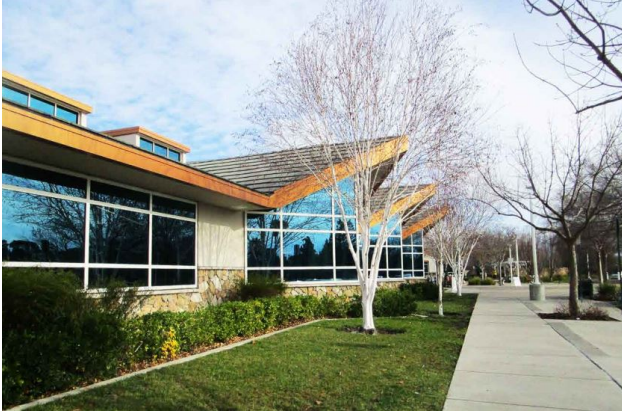
**Civic Center Library (Specific Enrichment Facility/General Usage)**

- Dormer Roof
- Gas-Fired Water Heater
- Carpet

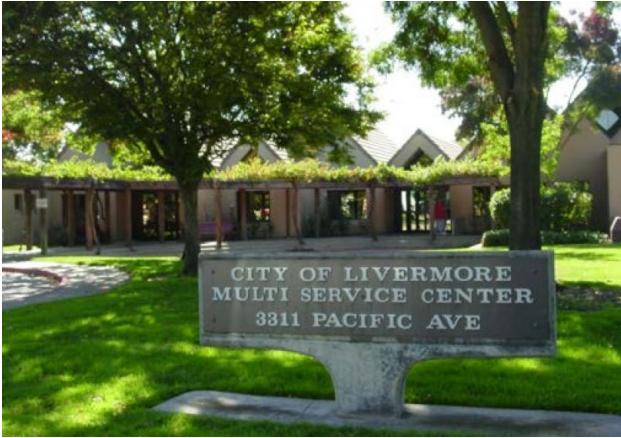
Multi Service Center (Specific Enrichment Facility/General Usage)

- Verify red breaker in electrical panel for fire alarm control panel as per NFPA 72 – 10.6.5.2.3.
- Electrical room being used for storage.
- Clearances not being kept at the electrical panels per CEC.
- Trellis is in need of repair or replacement.
- Roof gutters need to be cleaned.
- Water fountain not compliant.
- Review unisex/single stall restroom door hardware for compliancy with the code. Found a deadbolt and a push button lockset. May want to go to turn “Vacancy/No Vacancy” type of unit.

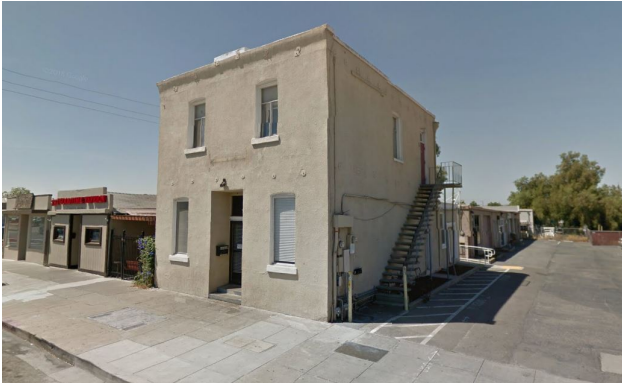
### 141 N Livermore Ave (Enrichment Facility/Specific Usage)

- Facility does not have a seismic gas shutoff valve on the gas meter as per Health and Safety Code 19180-19183.
- Structural cracking found.
- Street entrance not accessible.
- Upper level stairs and landing not CBC compliant.
- Rear ramp, landing, and handrails not compliant with CBC.
- Parking area needs to be restriped to meet accessible parking areas and path of travel.

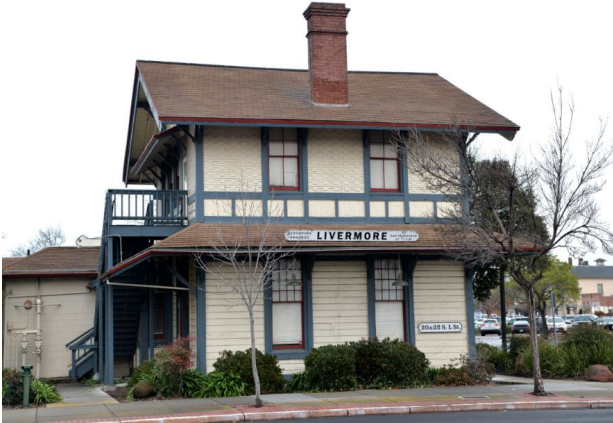
Railroad Train Depot Building (Enrichment Facility/Specific Usage)

- Facility does not have a seismic gas shutoff valve on the gas meter as per Health and Safety Code 19180-19183.
- Building looks in need of painting.
- Door hardware not compliant with existing code.
- Exterior railings not compliant with existing code.
- Some dry rot found on the exterior of the building need to be replaced.
- Roof damage found at eaves.
- Foundation of building needs to be reviewed for structural integrity.
- No accessibility to upper level found.
- Stairs/handrail to upper level is not code compliant and is missing the guardrail.

- Stairs to upper level need to be repaired or replaced.
- Built up roofing needs maintenance or needs to be replaced.

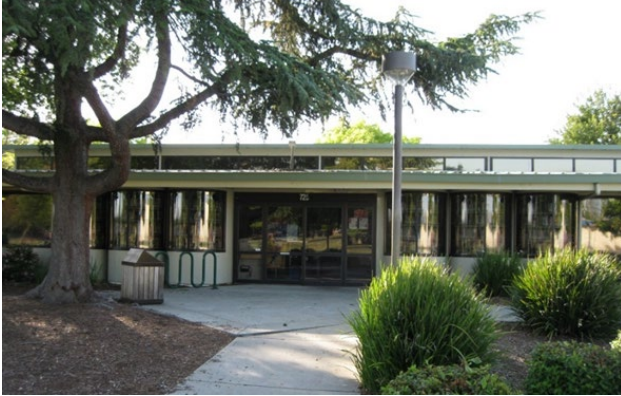
## Rincon Library (Enrichment Facility/Specific Usage)

- Facility does not have a seismic gas shutoff valve on the gas meter.
- Verify red breaker in electrical panel for fire alarm control panel as per NFPA 72 – 10.6.5.2.3.
- Door not compliant with CBC Chapter 11.
- Water fountain not compliant.
- Electrical room being used for storage.
- May want to provide panel and circuit numbers on the HVAC units.
- Verify that countertop height in restrooms meet CBC Chapter 11 requirements.
- Signage needs to be uniform and updated.
- Trees need to be trimmed and gutters cleaned.

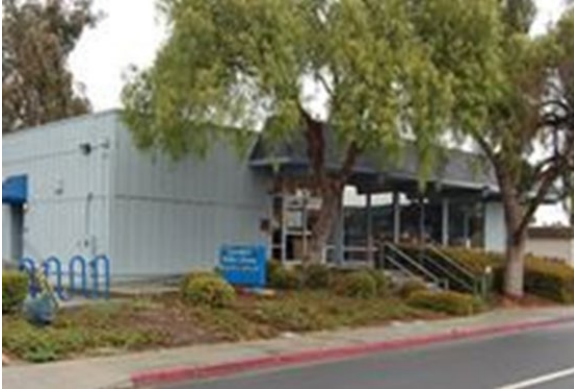
## Springtown Library (Enrichment Facility/Specific Usage)

- Facility does not have a seismic gas shutoff valve on the gas meter
- Verify red breaker in electrical panel for fire alarm control panel as per NFPA 72 – 10.6.5.2.3.
- Verify that roof ladder is in compliance with CALOSHA.
- Area around access ladder is being used for storage.
- Roof HVAC supply duct needs to be insulated.
- Verify clearances in restrooms.
- Siding damage found in various locations on the building.
- Verify that the railing for the stairs meet CBC requirements.
- Electrical panel looks to need rebuilding.
- Storage in front of electrical panel is not compliant with clearances noted within CEC.

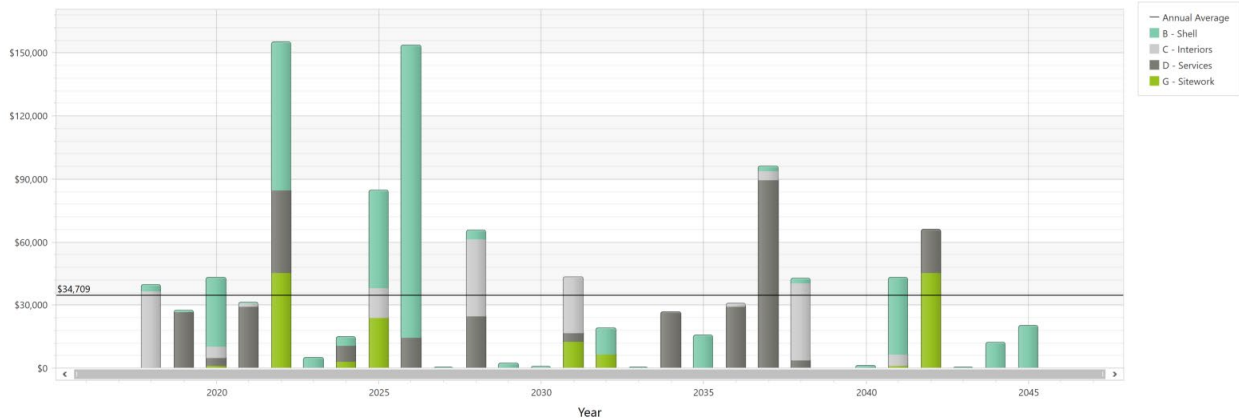
### Springtown Library Immediate Needs

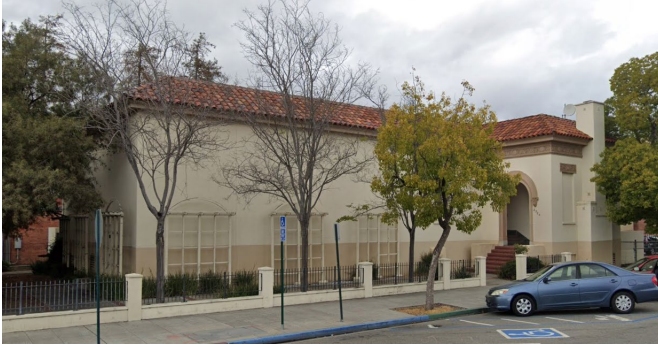
## Southern Bell Building (Enrichment Facility/Specific Usage)

- Found trouble alarms on the fire alarm control panel.
- Verify red breaker in electrical panel for fire alarm control panel as per NFPA 72 – 10.6.5.2.3.

- Structural cracks found in exterior wall.
- No accessible entry.
- Exit gate on street does not have egress panic hardware. May be required by code.
- Main entrance needs handrails.

- Roof ladders very unstable and need to be brought up to OSHA requirements.
- Lower and upper roofs need maintenance or replacement. Replacement should be in a maximum 5 years.

- Middle roof needs maintenance.
- Maintenance need on mansard roof mission tiles.
- Verify when filters have been changed on the building units. Looked in need of replacement.

- Provide panel and circuit numbers on the infrastructure units (HVAC, water heater, etc.), to better assist in maintenance or replacement.
- Electrical panels found to not have required clearances as per CEC.
